Concrete sewer pipe corrosion induced by sulphuric acid environment

Concrete Sewer Pipe Corrosion Induced by Sulphuric Acid Environment

Anna Romanova, Mojtaba Mahmoodian, Upul Chandrasekara, Morteza A. Alani

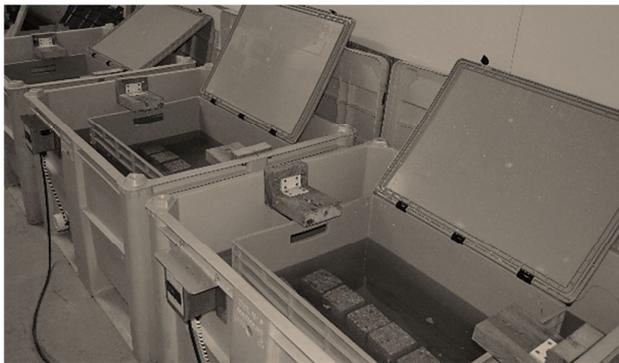
Fig. 1 Experimental set up of cubes being submerged into diluted sulphuric acid

The chamber hosted three 500L HDPE tanks where two of them were curing tanks and could autonomously control the fluid temperature inside them. Each of the tanks had a further 120L HDPE container, which was submerged by 2/3 into the fluid contained by 500L tank. This was done to create a thermal bath type effect and control a constant temperature of the solution in 120L containers. To avoid any fluctuation or displacement of the containers they were attached to the sides of the tanks by the use of L-type brackets. Three tanks: Tank 1, Tank 2 and Tank 3 maintained a constant temperature of solution located in containers of 10°C, 20°C and 30°C, respectively. The temperatures were chosen to represent the common range of effluent temperatures found in sewer pipes at different climate conditions. The temperature of Tank 1 was controlled by the environmental chamber which was set to deliver 10°C at a humidity level of 70%. Tank 2 and 3 temperatures were controlled autonomously by heating elements.

A total number of 45 cubes, cut out from brand-new circular concrete pipe were used in these experiments. Each cube had a measurement of 100x100x100mm and was cut with diamond-blade rotating saw, however as the process of cutting a circular pipe is very challenging and labour consuming a tolerance of 10% in each side measurement of the cube was allowed for. A number of 15 cubes were fully submerged into 0.5 pH solution of sulphuric acid in each of the containers in Tanks 1, 2 and 3. Further they were extracted at different points in time and assessed using different techniques to account for the corrosion level. Fig. 1 demonstrates a setup of tanks, containers and cubes located in the environmental chamber.

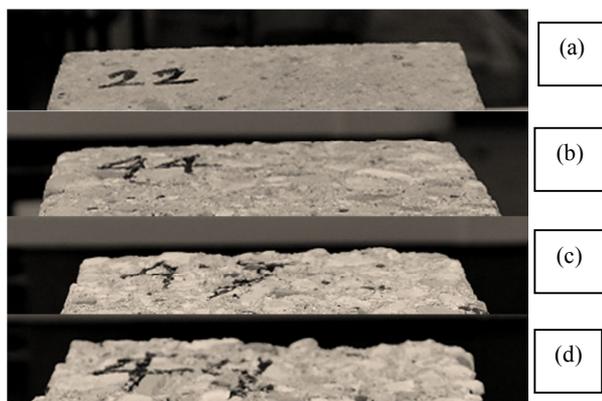
Fig. 2 Cube sample 22 before immersion (a), cube samples 44 after 28 days (b), cube sample 47 after 42 days (c) and cube sample 49 after 56 days of immersion (d)

A high resolution camera (Nikon D3200 SLR with 18-15 VR Lens) was used, where for each cube a picture at 45° angle to the top plane focusing on plane side was taken. These pictures were used to digitally estimate the roughness of the cube as a standard deviation of cube height from the edge-to-edge plane. In this study the calculated roughness was assumed to represent the level of corrosion. For each cube the corrosion depth was calculated as a difference of cube roughness before and after immersion.

The result of this study are summarised in Table I, where column 1 identifies the tank number (ABI are ‘all cubes before immersion’ and AAI are ‘all cubes after immersion’), followed by the number of days the cube was submerged in the solution and associated cube numbers. Column 4 shows the average of three cube’s mass after exposure into acid solution, followed by mass loss compared to original mass values and bulk density after exposure. Last column shows the corrosion level obtained from the digital photo-tests (Fig. 2 shows one cube side before immersion and three cubes ejected from acid solution at different days).

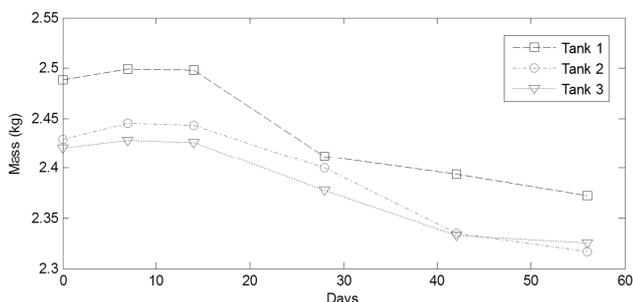
Fig. 3 Average mass of the cubes extracted at different days compared over three temperature regimes of sulphuric acid solution

At all temperature regimes, in the early stage of the experiments, at 7 and 14 days, when the corrosion process just begins to establish, an increase in overall mass of the cubes was observed (Fig. 3), similar finding was noted by [14]. On visual inspection, cube samples showed soft and hard white formations – gypsum and ettringite, however in the process of cube rinsing most of them were washed away. The fact that the cube mass was higher than before the immersion could be explained by the ability of concrete to absorb the acid via micro-pores where the formation of gypsum and ettringite also rapidly accelerates as the surrounding environment is constantly acidic. Phenomenon of ettringite formation was also reported in previous works; however, no data on change in mass was mentioned. Further, as expected, for measurement taken at 28, 42 and 56 days the mass of all samples in all containers decreased, where for tanks with temperatures of 20°C and 30°C the mass loss was higher than for tank with 10°C. The mass loss analysis for each individual group at

The increase in overall mass of the cubes proportionally affected the increase in bulk density for cubes examined at 7 and 14 days. Finding presented in Fig. 3 should be examined further and it is suggested that the cube samples should be subjected to systematic compression tests, as due to this chemical reaction their compressive strength and hence the durability may increase. For measurements after 14 days the density values decreased as expected. At days 42 and 56 the density value of cubes ejected from tank with temperature of 30°C was considerably lower than for the other two, which were similar.

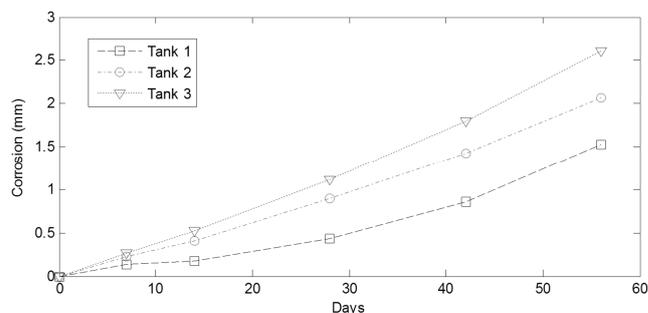
Fig. 4 Average corrosion depth of the cubes extracted at different days compared over three temperature regimes of sulphuric acid solution

The corrosion depth calculated from the photographic tests is shown in Fig. 4. For all temperature regimes at early stage of the experiment the corrosion depth increased by 0.22-0.45mm. Further, the discrepancy in corrosion depth increased between different temperature regimes. At 30°C, after 7 days, the corrosion process established quicker and continued to rapidly grow. For 10°C and 20°C the corrosion seemed to establish slower, however at 56 days the level of corrosion was tending towards corrosion observed in tank with 30°C solution, which was 1.52mm, 2.07mm and 2.61mm, respectively. Overall, at these three temperature regimes, if the corrosion rates were to progress linearly after 56 days, they would represent corrosion rates of 10mm/year, 13.5mm/year and 17mm/year, respectively. It is proposed that with time the same depth of corrosion will be observed in all tanks despite the temperature regime, however to validate the above assumption it is required to carry out experiment for a longer period of time.

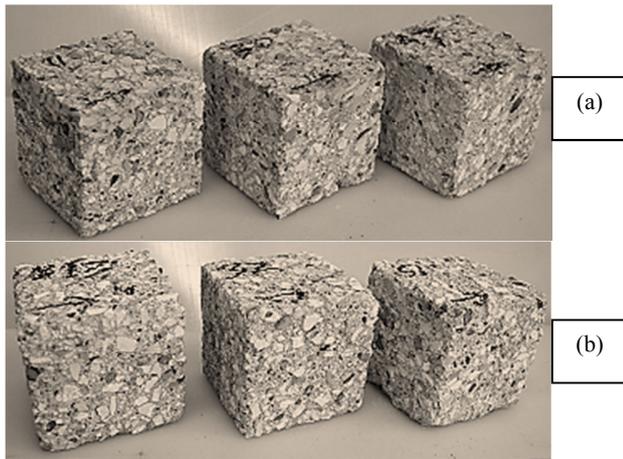
Fig. 5 Cube samples 11, 30 and 47 (left to right) after 42 days immersion into 0.5 pH sulphuric acid solution and temperatures of 10°C, 20°C and 30°C, respectively (a) and cube samples 13, 32 and 51 (left to right) after 56 days immersion into 0.5 pH sulphuric acid solution and temperatures of 10°C, 20°C and 30°C, respectively (b)

Interestingly that the leap between the cubes corrosion depth doubled in periods from 28 days to 42 days and then further between 42 days to 56 days which could be visibly assessed. Examples of such can we seen in Fig. 5.

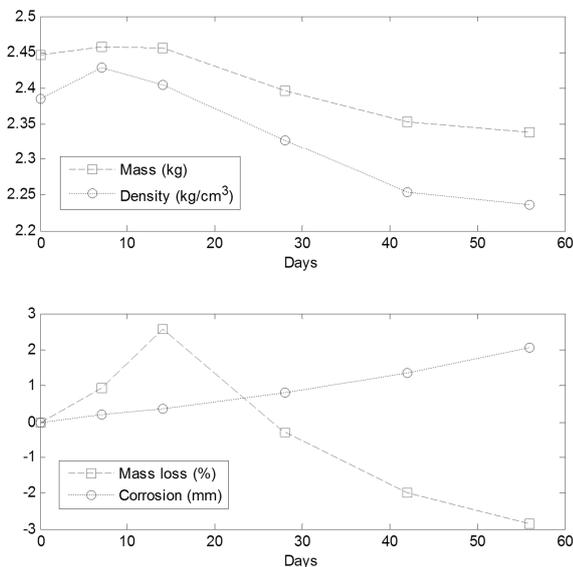
Fig. 6 Average mass, density, mass loss and corrosion level of the cubes extracted at different days from the sulphuric acid solution

Fig. 6 presents the average results of cube's mass, density, mass loss and corrosion depth for all temperature regimes, where the mass, density and mass loss increase in 0-14 days and further decline, whereas the corrosion depth increases with time from day one.
