Influence and Interaction of Temperature, H₂S and pH on Concrete Sewer Pipe Corrosion

Anna Romanova, Mojtaba Mahmoodian, Morteza A. Alani

Abstract—Concrete sewer pipes are known to suffer from a process of hydrogen sulfide gas induced sulfuric acid corrosion. This leads to premature pipe degradation, performance failure and collapses which in turn may lead to property and health damage. The above work reports on a field study undertaken in working sewer manholes where the parameters of effluent temperature and pH as well as ambient temperature and concentration of hydrogen sulfide were continuously measured over a period of two months. Early results suggest that effluent pH has no direct effect on hydrogen sulfide build up; on average the effluent temperature is 3.5°C greater than the ambient temperature inside the manhole and also it was observed that hydrogen sulfate concentration increases with increasing temperature.

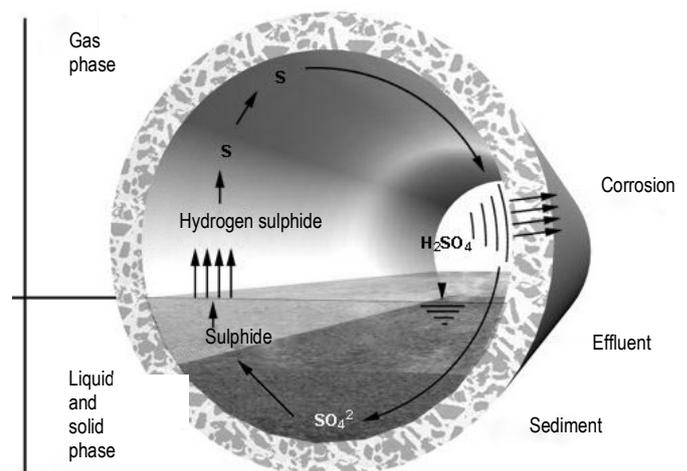
Fig. 1 Microbially induced concrete corrosion in sewer [19]

The process of sewer pipe corrosion has been studied since 1940th and a set of representative knowledge has been gained over years, which are referred to as microbially induced concrete corrosion (MICC) [12]. The bacteria class *Acidithiobacillus thiooxidans* [12]-[14] which are active in the effluent biofilm [15] convert sulphate to sulphide [16]. Some part of sulphide is released in atmosphere as gaseous hydrogen sulphide (H₂S) [16]. Further, the hydrogen sulphide is oxidised [17] to sulphuric acid (H₂SO₄), which subsequently attacks susceptible pipeline materials [18]. Fig. 1 demonstrates the chemical reaction of microbially induced concrete corrosion process in sewer pipe.

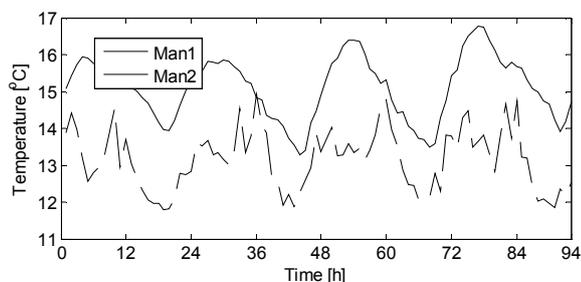
Fig. 1 Effluent temperature for Manhole 1 and Manhole 2 for a period of 4 days in the beginning of April shown in hours

The effluent temperatures for both manholes were found to follow very similar daily trend, however each of them has individual hourly pattern. Fig. 1 represents the data of effluent temperature recorded at a manhole 1 and manhole 2 in 5 days period in the beginning of April, where zero is set at 10am.

The data on Fig. 1 and for all other graphs was resampled to represent an average value for each given hour. Overall, in Feb-Apr the temperatures measurements minimum, maximum and mean for Man1 and Man2 were, 10.8°C, 17.1°C, 13.2°C and 11.6°C, 17.6°C, 15.1°C, respectively. In general the temperatures in Man2 are found to be higher and this is thought to be influenced by a closer location to the rising main, pumping station and generally the industrial sector which have larger use of hot water.

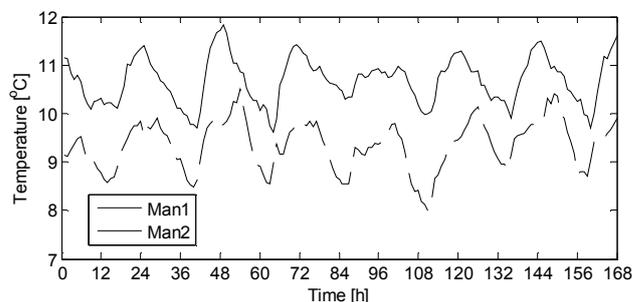
Fig. 2 Ambient temperature for Manhole 1 and Manhole 2 for a period of 1 week in the beginning of March shown in hours

The ambient temperatures for both manholes were found to follow overall an identical pattern. The general pattern of this behavior for both manholes is illustrated in Fig. 2, with zero set at midnight. From Fig. 2 it can be noted that the temperature in Man 1 is generally slightly lower for that compared with Man 2, with mean temperature values of 9.3°C and 10.6°C, respectively. Overall, in Feb-Apr the temperatures measurements minimum, maximum and mean for Man1 and Man2 were, 7.6°C, 12.9°C, 10°C and 8.7°C, 13.8°C, 11.2°C, respectively. The temperatures increased over the day with peak times at 11pm-4am after which they declined. This coincided with the discharge of overflow in the pumping station which generally takes place at midnight or when the chamber is full. However each manhole had manhole-specific minor pattern which is thought to be governed by house hold and industry activity in the area.

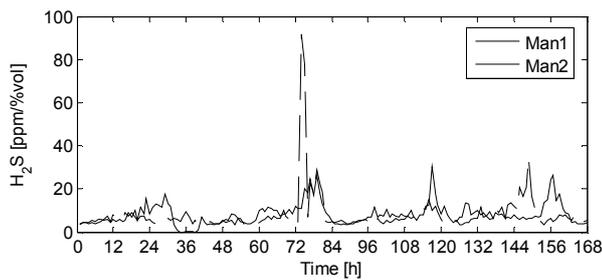
Fig. 3 Hydrogen sulphide concentration for Manhole 1 and Manhole 2 for a period of 1 week in the beginning of March shown in hours

The concentration of hydrogen sulphide for both of the manholes was measured with the sensor being placed in the middle of the manhole at 600mm above the effluent. The measurements of H₂S are presented on Fig. 3, where the data is shown for the same time period as in Fig. 2. From the figure it can be noted that the pattern of H₂S concentration is similar for both manholes even though they were located far apart and governed by different rising mains and pumping station conditions. Although, it should be noted that the operational time for all pumping stations in experimental area is the same. Graph identified large peak of H₂S at Manhole 1 at 91ppm/ % vol, where manhole 2 identifies only 29ppm/%vol. A similar peak tends to appear app. every 48h closer to midnight.

Overall, in Feb-Apr the measurements of the H_2S concentration minimum, maximum and mean for Man1 and Man2 were, 3, 134, 12 and 0, 168, 12, respectively. Even though the minimum and maximum values of both of the manholes varied, the mean of 12ppm/%vol was observed in both, whereas in most of the times a value of 3-5ppm/%vol was recorded.

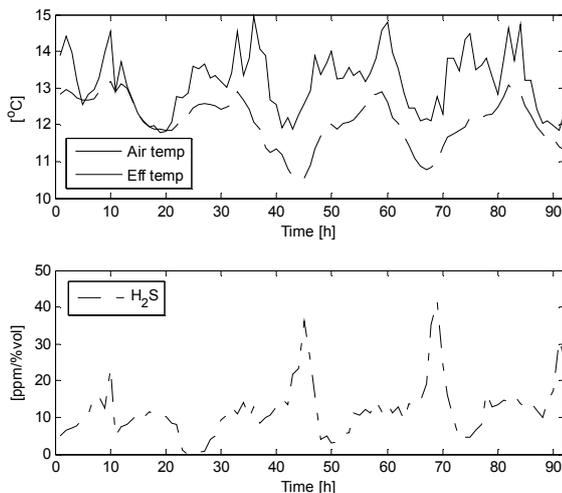
Fig. 4 Temperatures and hydrogen sulphide concentration for Manhole 1 for a period of 4 days in April shown in hours

The interaction between parameters of ambient temperature, effluent temperature and concentrations of hydrogen sulphide was investigated. Fig. 4 demonstrates the recorded data for the above for first four days in April for Manhole 1, with zero starting at 10am.

The data suggests that there is a relation between the ambient and effluent temperatures as they follow the same hourly pattern (which is governed by the effluent temperature, which in turn is related to domestic and industrial activities) and daily trend (governed by effluent temperature and general temperature of air outside the manhole). Furthermore, it can be noted that the H_2S level peaks together with the general decrease in temperature inside the manhole in late evening and early morning hours (during this time the general household and industrial activity is minimal, the flow levels are low to

moderate which allows for gas build-up). Furthermore, there is an apparent 10h shift in H_2S level increase and decrease behavior compared to temperatures. The above findings were confirmed for both of the manholes during Feb-Apr period.
