Road foundation detailing using ground penetrating radar systems with different frequencies

Assessment of the Underground Construction Details of a Road Pavement Using GPR Antenna Systems with Different Frequencies

A.M. Alani¹, F. Tosti¹, L. Bianchini Ciampoli², F. Benedetto³

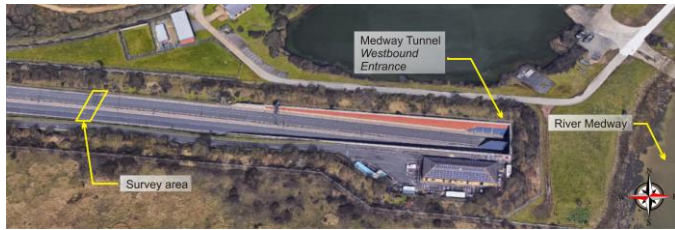
Fig. 1. Bird's-eye view of the survey area.

The investigated road is located in close proximity to the westbound entrance of the Medway Tunnel (Fig. 1). This tunnel passes under the River Medway and links Strood with Chatham in Kent, England.
