Non-Destructive Assessment of a Historic Masonry Arch Bridge Using Ground Penetrating Radar and 3D Laser Scanner

Amir M. Alani¹, Fabio Tosti¹, Kevin Banks², Luca Bianchini Ciampoli³, Andrea Benedetto³

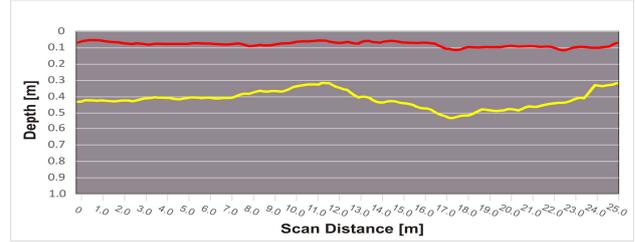
Fig. 3. Average total depth of asphalt (red line) and base layers (yellow line) within the bridge deck area.

Results from the 2000 MHz antenna system enlightened that the average thickness of the upper asphalt layer was 7 cm. The average total depth from the bridge surface to the historic stonework was 41 cm (Fig. 3). There was considerable variation in the thickness of both layers (e.g., Fig. 4), due to the bridge’s construction and the large areas of resurfacing. With regards to the location of the ties and the modelling of the whole structure, the 200 MHz and 600 MHz dual frequency antenna system was able to identify the reinforcing bars (Fig. 5a). Location was confirmed by the modelling made using the laser scanner (Fig. 5b).

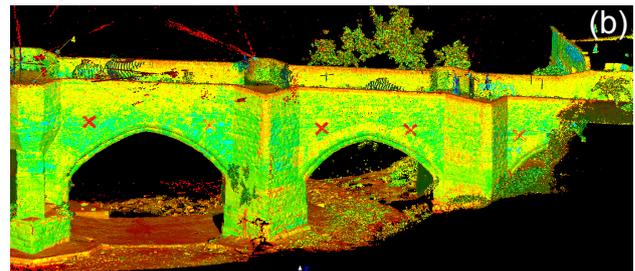
Fig. 5. Reinforcing bars identified by (a) the 600 MHz GPR (circles) and (b) the laser scanner (red crosses).
