Sustainable conditional tunnel inspection: London Underground UK

Manuscript title: Sustainable Conditional Tunnel Inspection: London Underground

Authors: Ali Bahadori-Jahromi¹, Abdulazeez Rotimi¹ and Andrew Roxan²

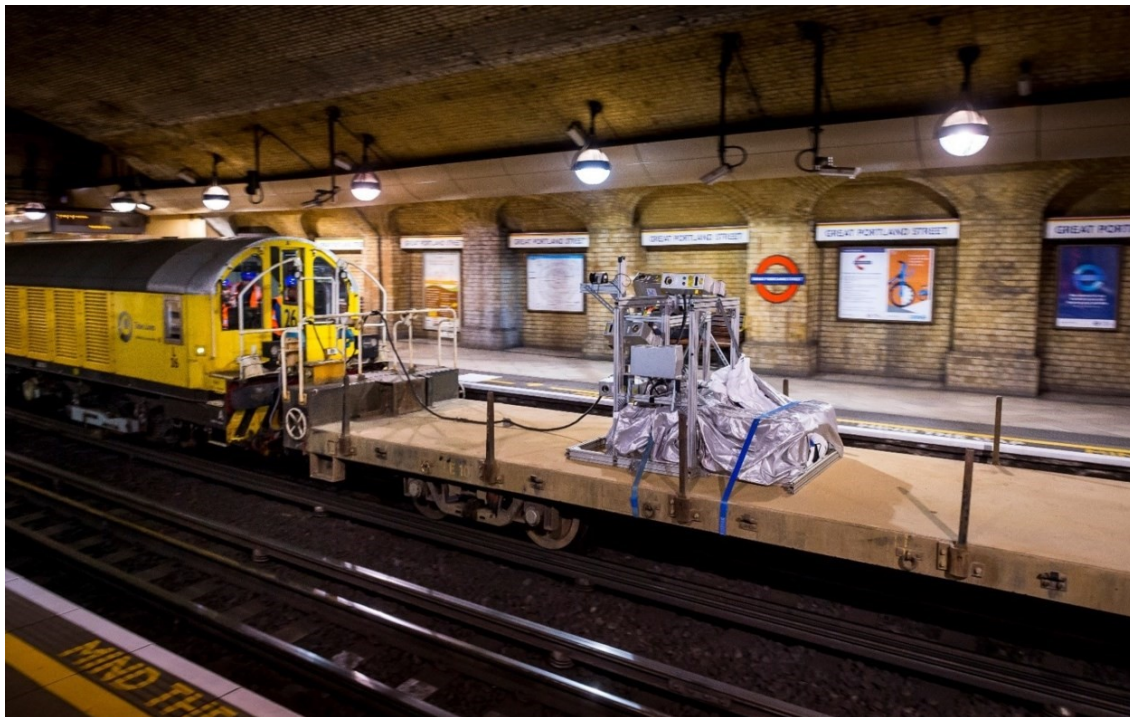
Figure 4. Laser train in use

Once all the data has been processed and digitalised, the data can be analysed offline by the operator using a 3D viewing software. From the software and input data, the operator can precisely measure any defects to the tunnel lining and collaborate all their findings in the form of graphs or an inspection report, produced by the computer software (Tunnel Viewer). In masonry tunnels the software can detect deformation, fractures to the brickwork, joint loss to the mortar, dampness to an area of the tunnel and face loss (spalling) to the brickwork. In cast iron tunnels, the software can detect missing bolts, seepage, fractures and deformation. Finally, in concrete tunnels spalling, fractures, deformation and honeycombing. Figures 3 and 4 show the LTSS laser train arrangement and Laser train in use respectively.

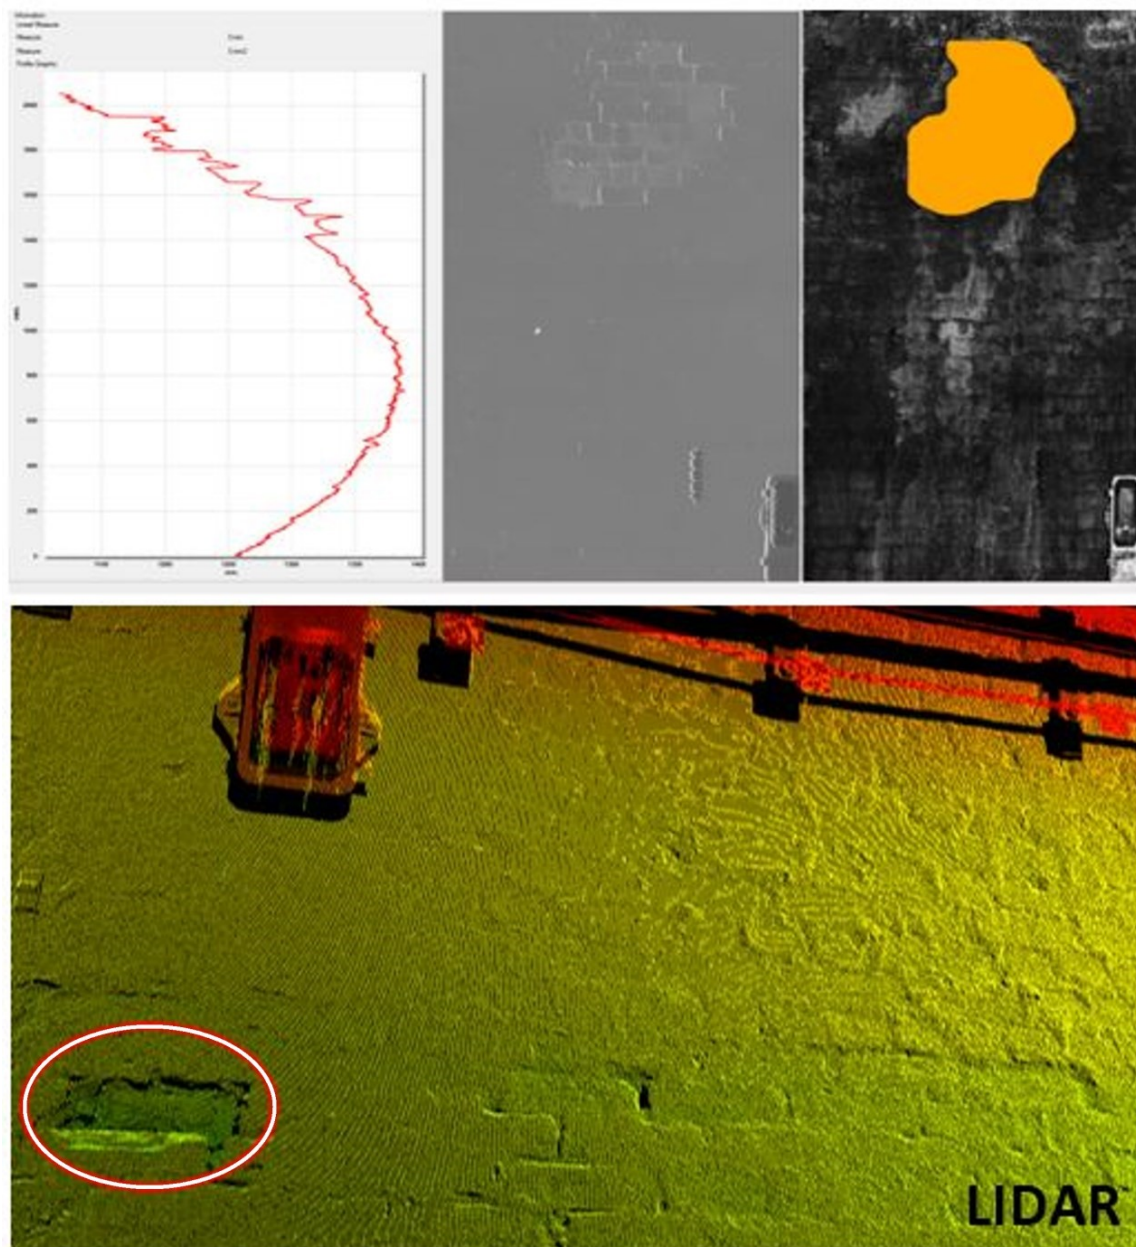
Figure 9. Face loss identification by Tunnel Viewer software (Euroconsult 2017)

Face loss also occurs to old brick work, especially those exposed to weathering. This is when the face of the brickwork breaks away often in large pieces in a large section of brickwork. It can also lead to a serious defect in a tunnel if left unattended, particularly in the crown above the train path. Repairs can be done by cutting out the bricks and replacing them where required, however as before this needs to be identified. The Tunnel Viewer software uses the parameters set to determine the loss of face to the brickwork as shown in *figures 9*.

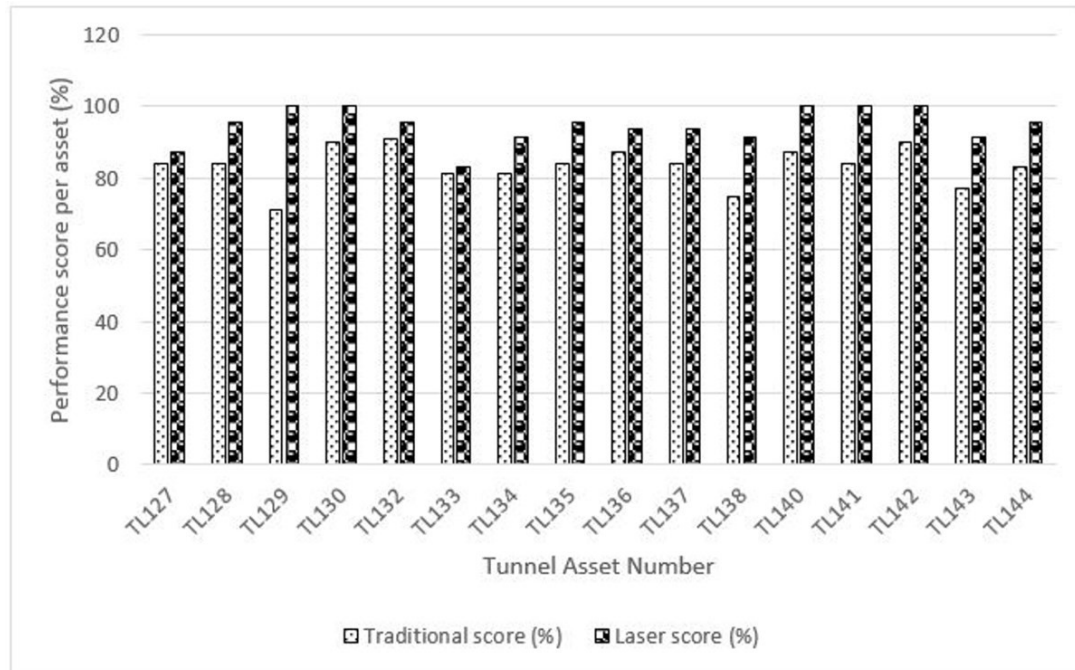
Figure 13. Brick Tunnel Score Comparisons Traditional method vs. Laser Survey NDT Inspections

Table 3 and figure 13 show the previous inspection results of the brick tunnels between Baker Street and Finchley Road using the traditional NDT method against the results of the software scored in relation to the data obtained from the laser inspection.

It can be observed from figure 13 that the laser inspection data result scores from the software are higher than the traditional scores for all the assets. This shows that many of the brick tunnels are generally in a good condition with few tunnels indicating only minor issues.

None of the assets apart from TL133 and TL137 require maintenance work until at least after the next Principal Inspection due to their high score. If the traditional scores were to be used, nearly all of the brick tunnels would require scheduled maintenance work before the next Principal Inspection at a substantial cost to the maintenance budget. Therefore, the laser tunnel inspection significantly reduces the contractor work shifts. Table 4 presents the London Underground Standard requirement in regard to the scores of an asset and recommended maintenance action.
