# Influence and Interaction of Temperature, H<sub>2</sub>S and pH on Concrete Sewer Pipe Corrosion

Anna Romanova, Mojtaba Mahmoodian, Morteza A. Alani

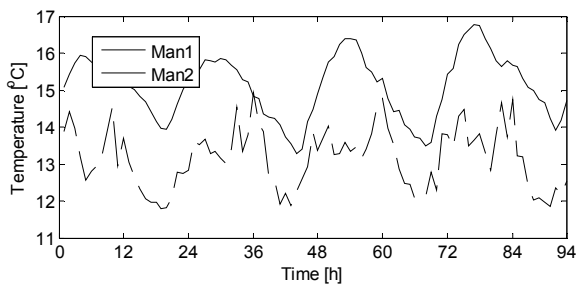
Fig. 1 Effluent temperature for Manhole 1 and Manhole 2 for a period of 4 days in the beginning of April shown in hours

The effluent temperatures for both manholes were found to follow very similar daily trend, however each of them has individual hourly pattern. Fig. 1 represents the data of effluent temperature recorded at a manhole 1 and manhole 2 in 5 days period in the beginning of April, where zero is set at 10am.

The data on Fig. 1 and for all other graphs was resampled to represent an average value for each given hour. Overall, in Feb-Apr the temperatures measurements minimum, maximum and mean for Man1 and Man2 were, 10.8°C, 17.1°C, 13.2°C and 11.6°C, 17.6°C, 15.1°C, respectively. In general the temperatures in Man2 are found to be higher and this is thought to be influenced by a closer location to the rising main, pumping station and generally the industrial sector which have larger use of hot water.

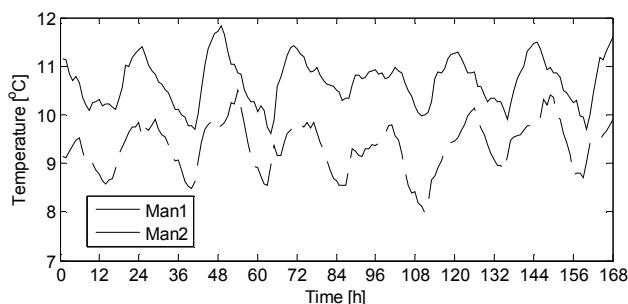
Fig. 2 Ambient temperature for Manhole 1 and Manhole 2 for a period of 1 week in the beginning of March shown in hours

The ambient temperatures for both manholes were found to follow overall an identical pattern. The general pattern of this behavior for both manholes is illustrated in Fig. 2, with zero set at midnight. From Fig. 2 it can be noted that the temperature in Man 1 is generally slightly lower for that compared with Man 2, with mean temperature values of 9.3°C and 10.6°C, respectively. Overall, in Feb-Apr the temperatures measurements minimum, maximum and mean for Man1 and Man2 were, 7.6°C, 12.9°C, 10°C and 8.7°C, 13.8°C, 11.2°C, respectively. The temperatures increased over the day with peak times at 11pm-4am after which they declined. This coincided with the discharge of overflow in the pumping station which generally takes place at midnight or when the chamber is full. However each manhole had manhole-specific minor pattern which is thought to be governed by house hold and industry activity in the area.

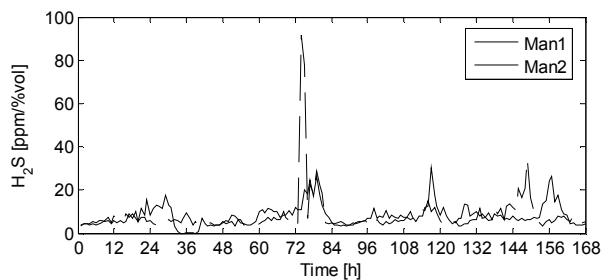
Fig. 3 Hydrogen sulphide concentration for Manhole 1 and Manhole 2 for a period of 1 week in the beginning of March shown in hours

The concentration of hydrogen sulphide for both of the manholes was measured with the sensor being placed in the middle of the manhole at 600mm above the effluent. The measurements of H<sub>2</sub>S are presented on Fig. 3, where the data is shown for the same time period as in Fig. 2. From the figure it can be noted that the pattern of H<sub>2</sub>S concentration is similar for both manholes even though they were located far apart and governed by different rising mains and pumping station conditions. Although, it should be noted that the operational time for all pumping stations in experimental area is the same. Graph identified large peak of H<sub>2</sub>S at Manhole 1 at 91ppm/ % vol, where manhole 2 identifies only 29ppm/%vol. A similar peak tends to appear app. every 48h closer to midnight.

Overall, in Feb-Apr the measurements of the  $H_2S$  concentration minimum, maximum and mean for Man1 and Man2 were, 3, 134, 12 and 0, 168, 12, respectively. Even though the minimum and maximum values of both of the manholes varied, the mean of 12ppm/%vol was observed in both, whereas in most of the times a value of 3-5ppm/%vol was recorded.

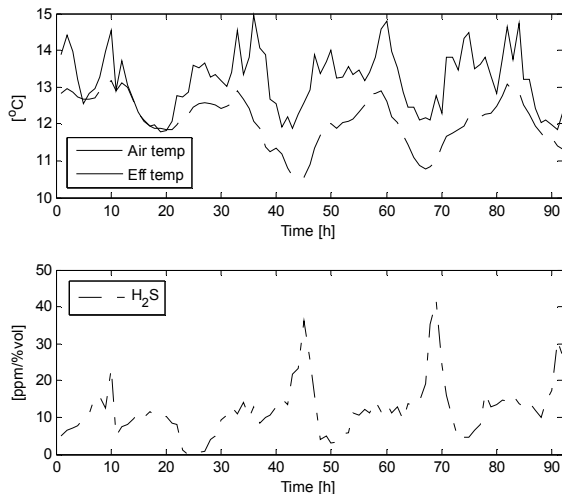
Fig. 4 Temperatures and hydrogen sulphide concentration for Manhole 1 for a period of 4 days in April shown in hours

The interaction between parameters of ambient temperature, effluent temperature and concentrations of hydrogen sulphide was investigated. Fig. 4 demonstrates the recorded data for the above for first four days in April for Manhole 1, with zero starting at 10am.

The data suggests that there is a relation between the ambient and effluent temperatures as they follow the same hourly pattern (which is governed by the effluent temperature, which in turn is related to domestic and industrial activities) and daily trend (governed by effluent temperature and general temperature of air outside the manhole). Furthermore, it can be noted that the  $H_2S$  level peaks together with the general decrease in temperature inside the manhole in late evening and early morning hours (during this time the general household and industrial activity is minimal, the flow levels are low to

moderate which allows for gas build-up). Furthermore, there is an apparent 10h shift in  $H_2S$  level increase and decrease behavior compared to temperatures. The above findings were confirmed for both of the manholes during Feb-Apr period.
