Non-destructive assessment of a historic masonry arch bridge using ground penetrating radar and 3D laser scanner

# Non-Destructive Assessment of a Historic Masonry Arch Bridge Using Ground Penetrating Radar and 3D Laser Scanner

The Old Bridge at Aylesford (UK) is a multi-span bridge dating from around 1250 (Fig. 1).

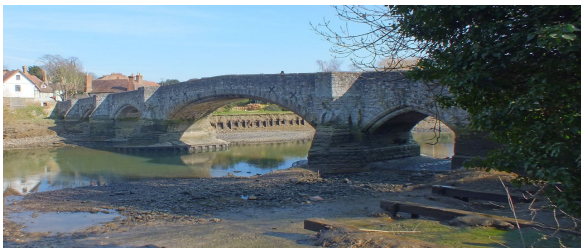
Fig. 1. The Old Bridge at Aylesford in Kent, UK.

Fig. 2. The Old Bridge: depiction of the survey zones.

The bridge is constructed of local “ragstone” with seven arches including a central segmental arch and six pointed and double-chamfered outer arches. The bridge width is about 4 m between the centres of the stone-coped parapet. The end arches are partly buried by the river bank. The stone piers have cutwaters on the upstream and downstream sides on rebuilt concrete foundations. On each side are octagonal and triangular canted pedestrian refuges resting on buttresses over the piers. Below the bridge is a barge-bed constructed from large baulks of timber. The bridge underwent a major alteration in the early 1800s, when the two central arches were replaced by a single arch of 18 m span, removing a pier to allow passage for larger river traffic [10].

The system consists of two rows of eight double polarized 2000 MHz antennas with 10 cm spacing and allows scanning with a footprint 80 cm wide. The bridge deck was surveyed collecting four longitudinal scans spaced equally, that were performed along the length of the bridge. Transversal scans (i.e., scans across the bridge) were not collected. For data management purposes, the survey was divided into three ‘Zones’ (Fig. 2).
