Sustainable conditional tunnel inspection: London Underground UK

Manuscript title: Sustainable Conditional Tunnel Inspection: London Underground

Authors: Ali Bahadori-Jahromi¹, Abdulazeez Rotimi¹ and Andrew Roxan²

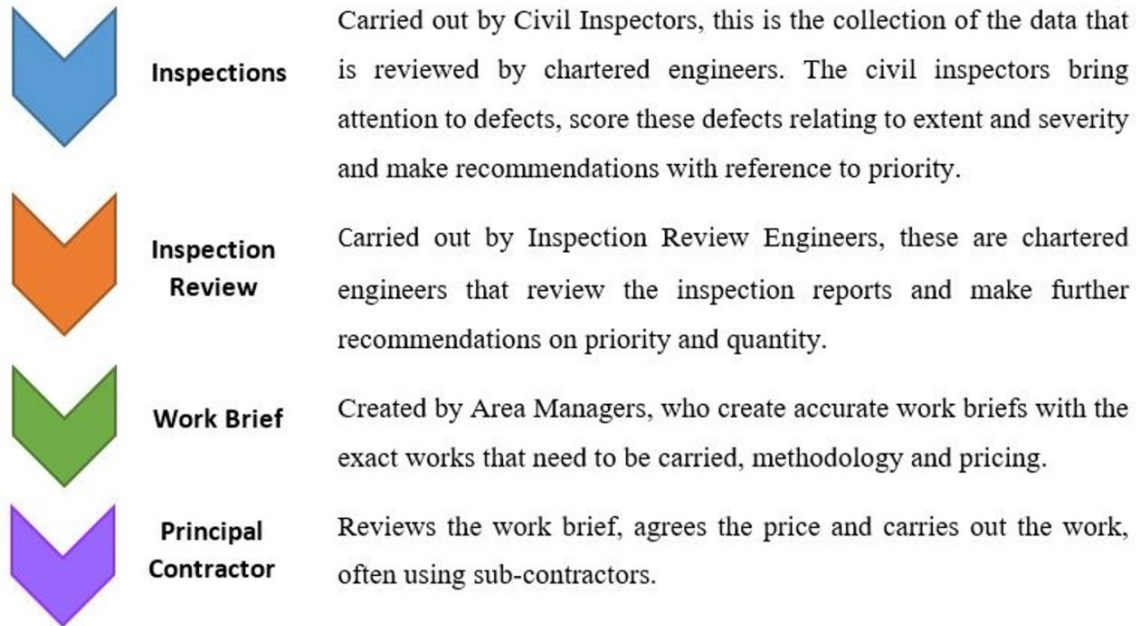
Figure 1. Flow Chart; London Underground Maintenance

The maintenance process employed by London underground is presented in figure 1. The process ensures that the underground London is undisrupted and prevent potential injury or death to its customers or staff. By strengthening the inspection stage, it allows the subsequent

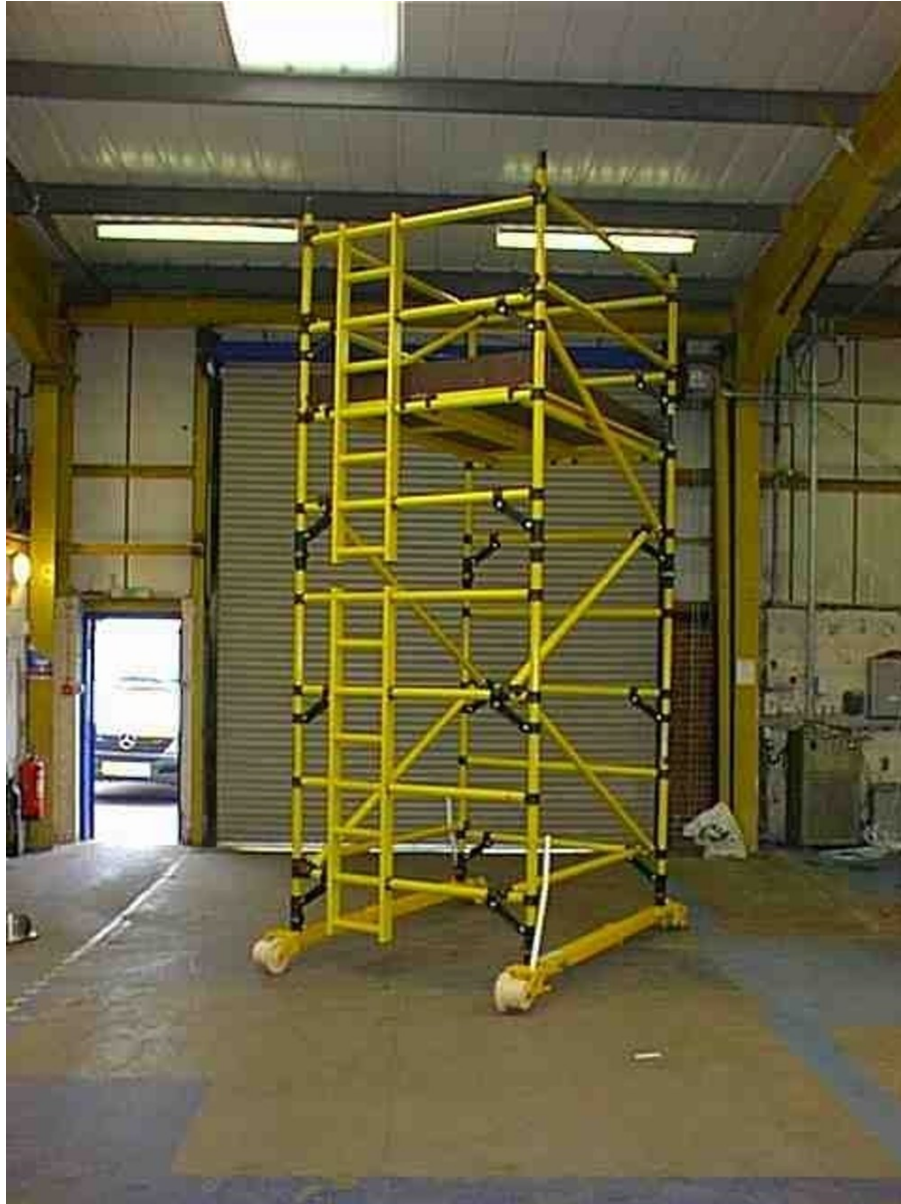
Figure 2. Rotamag tower setup used for traditional NDT method (Permaquip 2016)

Currently, the traditional method is carried out using a Rotamag scaffold tower fitted onto a track trolley (figure 2) and pushed through the tunnel on foot to carry out the inspection of the asset. The inspector will then create tunnel charts which are hand drawn and scanned into the computer, this usually reduce their quality and makes them difficult to read. The next inspection of the tunnel is subsequently conducted four years later where an inspector will need to be able to read the charts clearly to see if any further defects have occurred.

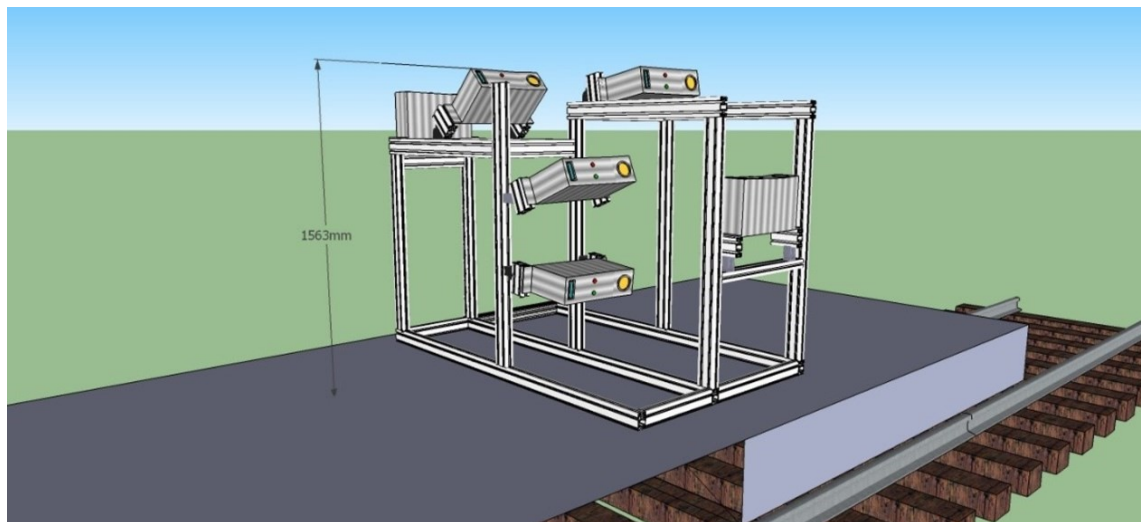
Figure 3. LTSS laser train arrangement

Once all the data has been processed and digitalised, the data can be analysed offline by the operator using a 3D viewing software. From the software and input data, the operator can precisely measure any defects to the tunnel lining and collaborate all their findings in the form of graphs or an inspection report, produced by the computer software (Tunnel Viewer). In masonry tunnels the software can detect deformation, fractures to the brickwork, joint loss to the mortar, dampness to an area of the tunnel and face loss (spalling) to the brickwork. In cast iron tunnels, the software can detect missing bolts, seepage, fractures and deformation. Finally, in concrete tunnels spalling, fractures, deformation and honeycombing. Figures 3 and 4 show the LTSS laser train arrangement and Laser train in use respectively.

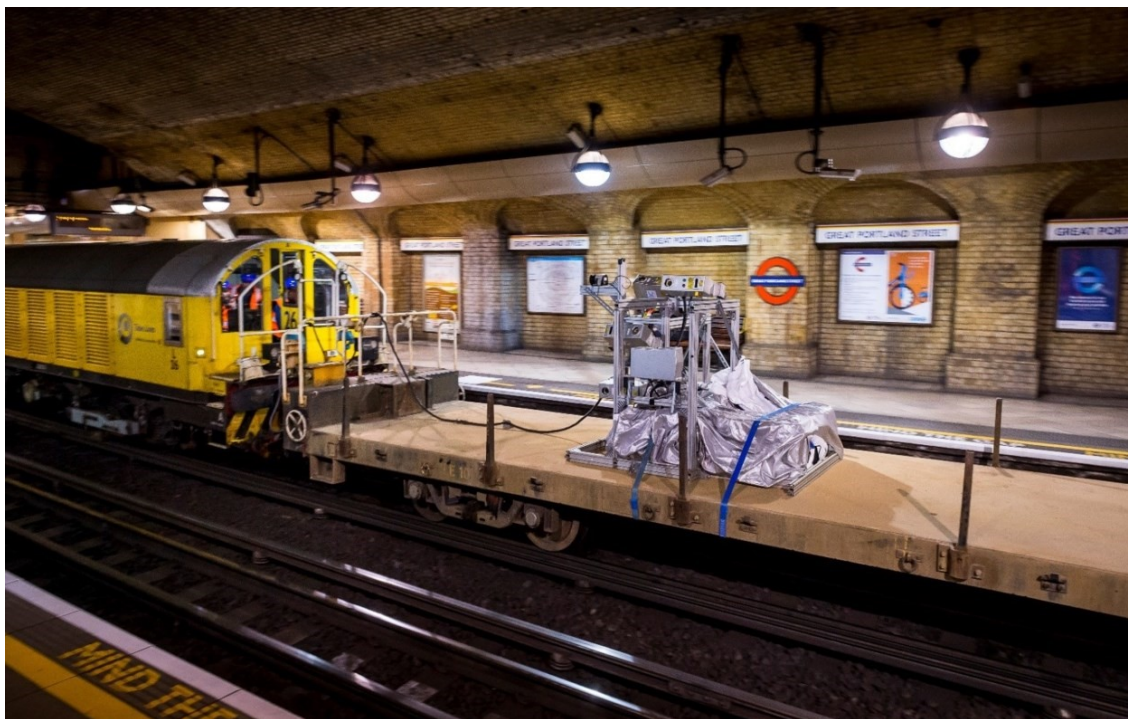
Figure 4. Laser train in use

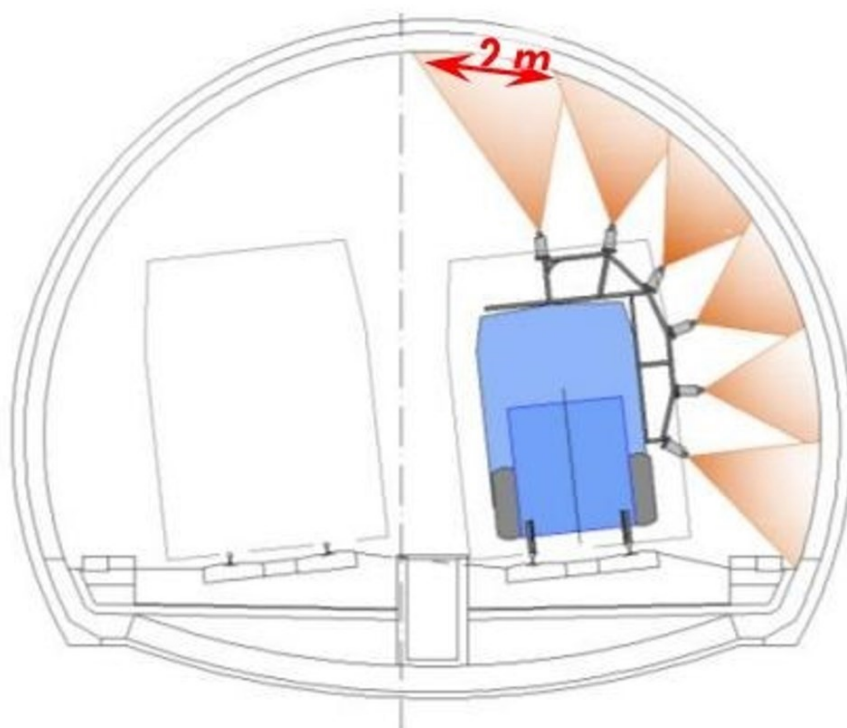
Figure 5. Typical diagram showing scanners used to collect the tunnel profile data (Pavemetrics 2016)

Tunnel surfaces with an arc length of less than 12m can be inspected with just one pass of the lasers, however if they are over 12m then the surfaces will be captured through multiple passes (usually forwards then backwards), with the captured images being stitched together to

get the correct data. Figure 5 presents a typical diagram showing how the scanners captures data from a brick tunnel.

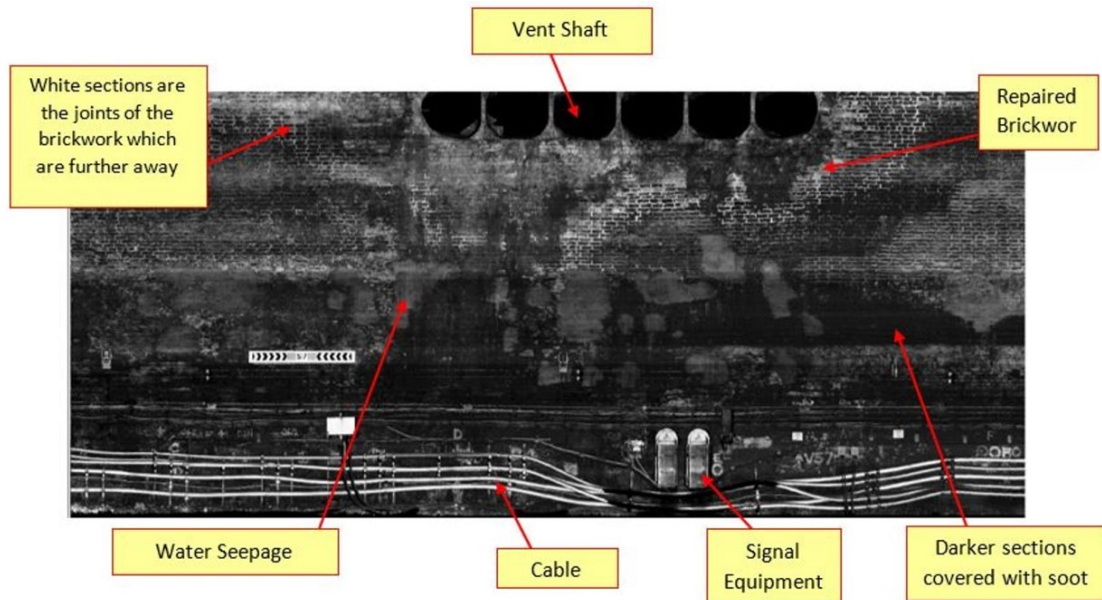
Figure 7. Labelled typical tunnel cross-sectional view (Euroconsult 2017)

The computer software, Tunnel Viewer used to process the data captured with the laser tunnel inspection enables zooming into a particular defect to carry out further analysis and evaluations. A measuring tool within the program enables the geometry including the surface width and depth of individual defects to be computed. The measuring tool can be used to calculate joint loss, fractures, spalled areas and the amount of seepage to a specific area. This tool will not only measure one effected area but the whole asset, thereby providing the inspector with a better insight into a particular defect that may be a cause of concern. This feature of the software is particularly good as these types of defects would have had to be measured on site, whereas they can all be carried out off site with higher degree of accuracy. The software also provides cross-sectional view of the asset from all the points collected on site using the laser,

digital cameras and using the angle of triangulation with computer algorithms to form a grey scaled reconstructed profile of the brick tunnel. *Figure 7* is labelled below identifying what each part of the grayscale image means.

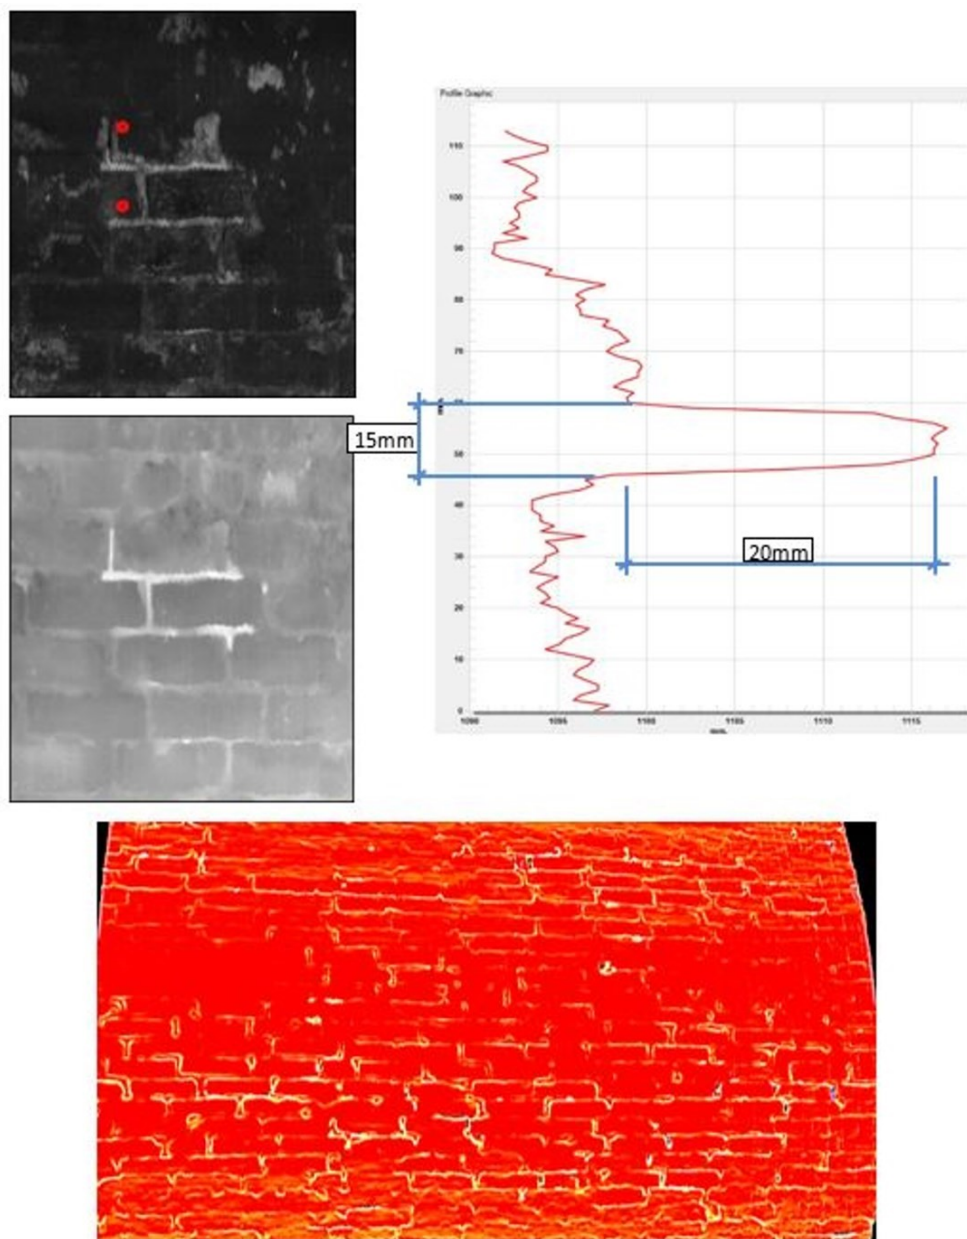
Figure 8. Joint loss identification by Tunnel Viewer software (Euroconsult 2017)

Joint loss occurs when there is mortar loss in the brick joints. This is a very common defect in old masonry but can also be caused from frost damage. If left unattended, it can result to weakened and loose bricks. The mortar can be easily be replaced by a maintenance process called re-pointing, where new mortar is added to the joints. It is a major concern having loose bricks within a tunnel carrying up to 33 trains per hour. London Underground has a contract to repair any joint loss required for a year, but to do this, it must be correctly identified. The laser train does this, and also identifies the location of the joint loss in the tunnel. This informs the contractor if a rotamag tower is required in the case of highly located repair works. Previously the inspector would have had to identify joint loss using tunnel charts (figure 6) which are often hard to read. The Tunnel Viewer software can identify the exact amount of brick loss in the tunnel and comparison can be made to subsequent scheduled principal inspection run. Therefore, the department can evaluate the exact extent of the tunnel that has been successfully repaired. This is useful for maintenance records and for budget forecasting. Figure 8 shows the Tunnel Viewer software identifying joint loss within a tunnel.
