Sustainable conditional tunnel inspection: London Underground UK

Manuscript title: Sustainable Conditional Tunnel Inspection: London Underground

Authors: Ali Bahadori-Jahromi¹, Abdulazeez Rotimi¹ and Andrew Roxan²

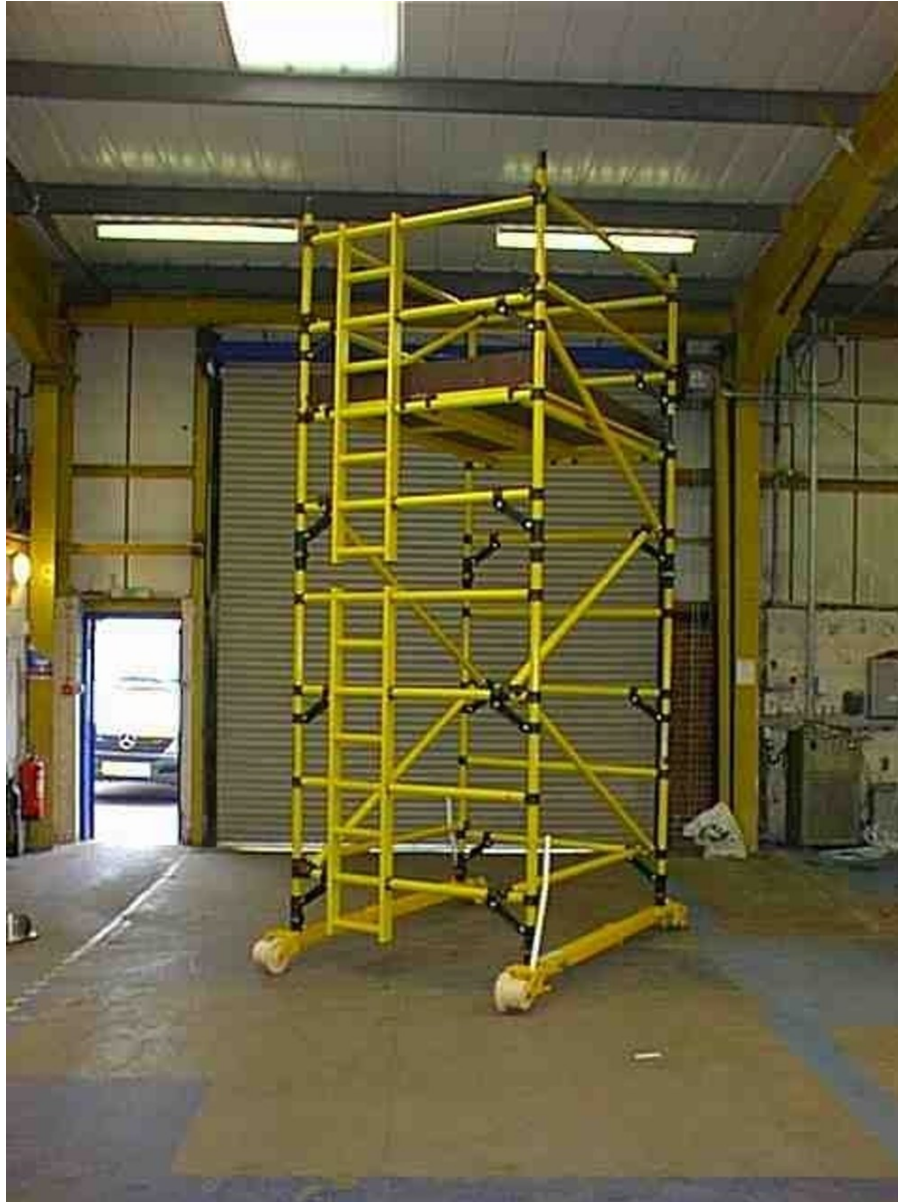
Figure 2. Rotamag tower setup used for traditional NDT method (Permaquip 2016)

Currently, the traditional method is carried out using a Rotomag scaffold tower fitted onto a track trolley (figure 2) and pushed through the tunnel on foot to carry out the inspection of the asset. The inspector will then create tunnel charts which are hand drawn and scanned into the computer, this usually reduce their quality and makes them difficult to read. The next inspection of the tunnel is subsequently conducted four years later where an inspector will need to be able to read the charts clearly to see if any further defects have occurred.

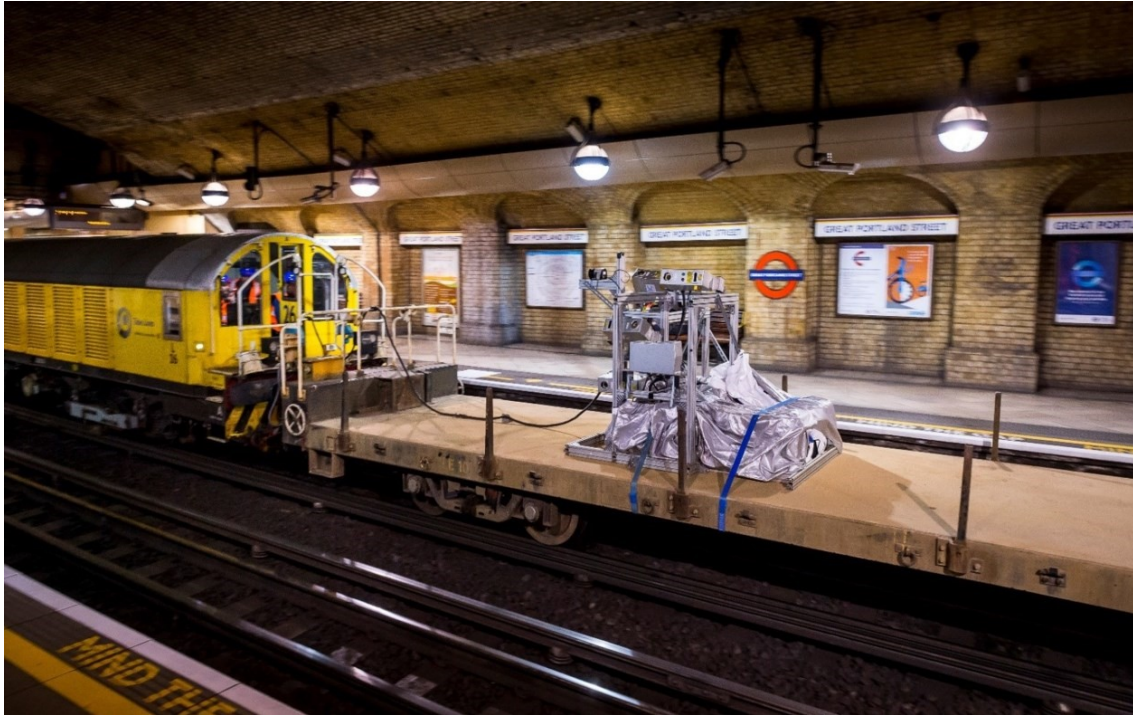
Figure 4. Laser train in use

Once all the data has been processed and digitalised, the data can be analysed offline by the operator using a 3D viewing software. From the software and input data, the operator can precisely measure any defects to the tunnel lining and collaborate all their findings in the form of graphs or an inspection report, produced by the computer software (Tunnel Viewer). In masonry tunnels the software can detect deformation, fractures to the brickwork, joint loss to the mortar, dampness to an area of the tunnel and face loss (spalling) to the brickwork. In cast iron tunnels, the software can detect missing bolts, seepage, fractures and deformation. Finally, in concrete tunnels spalling, fractures, deformation and honeycombing. Figures 3 and 4 show the LTSS laser train arrangement and Laser train in use respectively.

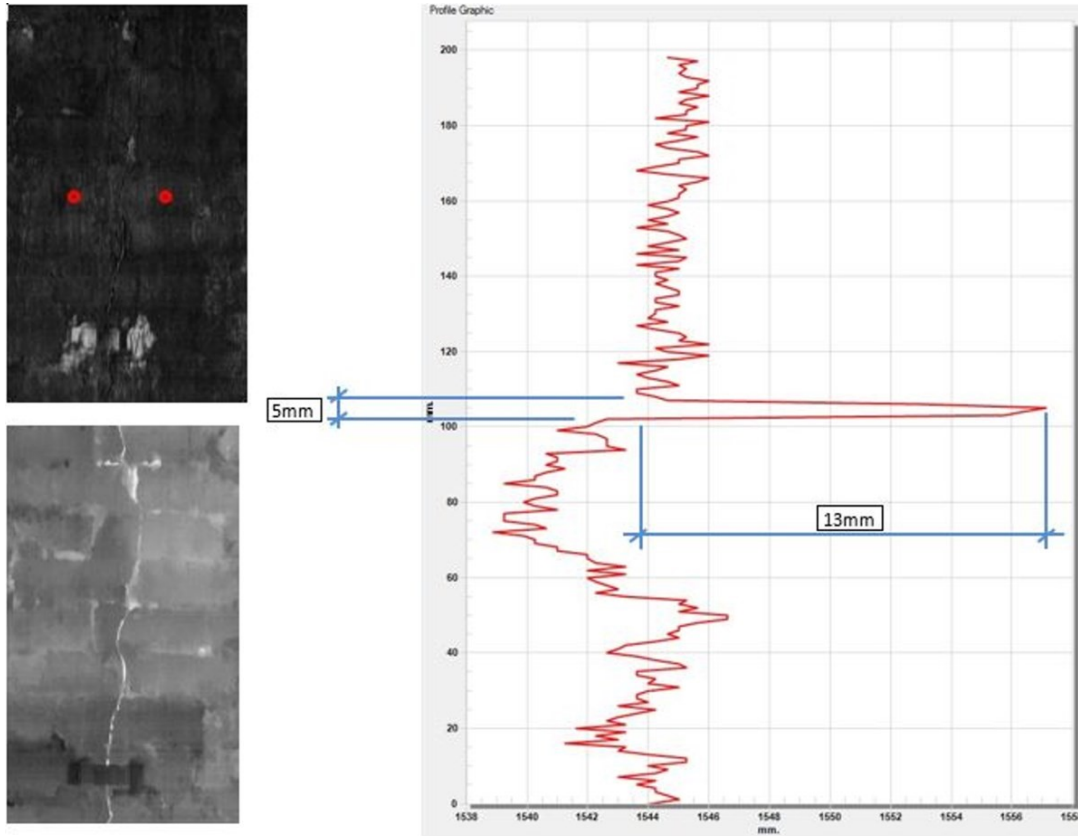
Figure 10. Identification of fracture by Tunnel Viewer software (Euroconsult 2017)

Fractures can present enormous safety hazards within tunnels and have several causes, but it is usually caused by movement within the tunnel. There is often an underlying problem with the tunnel when fractures occur. Fractures can lead to loosen brickwork and equipment that could result in the train service becoming affected. Traverse fractures present a more serious defect than longitudinal fractures as they indicate flattening of the arch and possible rotation of the tunnel. However longitudinal fractures are more common and related to lack of load distribution. The Tunnel Viewer software identifies fractures as shown in figure 10. It provides the length, depth and width of the fracture at the worst point. The Tunnel Viewer software can then be used to measure the fracture at any point required. With the reference function in future scans, the fracture can be overlaid to measure any change.

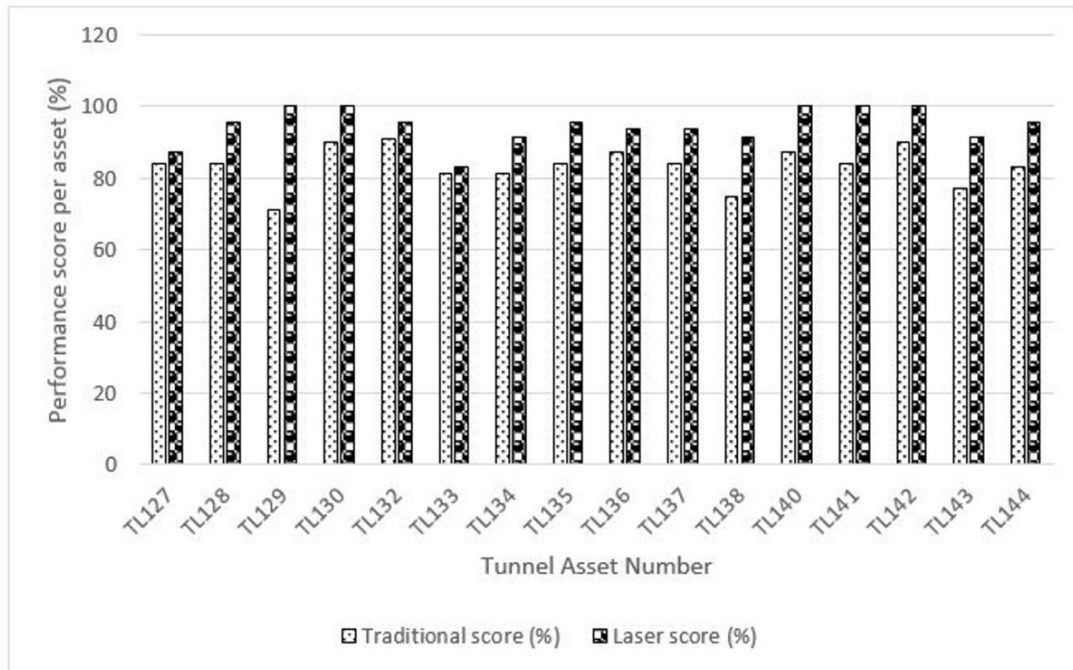
Figure 13. Brick Tunnel Score Comparisons Traditional method vs. Laser Survey NDT Inspections

Table 3 and figure 13 show the previous inspection results of the brick tunnels between Baker Street and Finchley Road using the traditional NDT method against the results of the software scored in relation to the data obtained from the laser inspection.

It can be observed from figure 13 that the laser inspection data result scores from the software are higher than the traditional scores for all the assets. This shows that many of the brick tunnels are generally in a good condition with few tunnels indicating only minor issues.

None of the assets apart from TL133 and TL137 require maintenance work until at least after the next Principal Inspection due to their high score. If the traditional scores were to be used, nearly all of the brick tunnels would require scheduled maintenance work before the next Principal Inspection at a substantial cost to the maintenance budget. Therefore, the laser tunnel inspection significantly reduces the contractor work shifts. Table 4 presents the London Underground Standard requirement in regard to the scores of an asset and recommended maintenance action.
