Experimental behavior of full-scale exterior beam-column space joints  
retrofitted by ferrocement layers under cyclic loading

## Case study

## Experimental behavior of full-scale exterior beam-column space joints retrofitted by ferrocement layers under cyclic loading

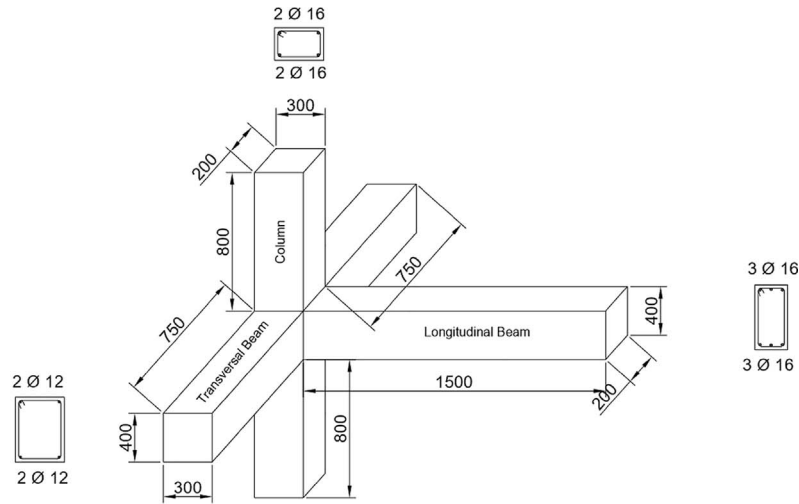
(a) Specimen dimensions (mm)

Fig. 1. Schematic diagrams for test specimens and formwork.

The experimental program consisted of eleven beam-column space joints subjected to cyclic loading. The test specimens simulate exterior beam-column space joints in a multistory building. The beam length represents half the span length of the bay, while the column height represents the column height from the mid height of one story to the mid height of the next one. The boundary conditions are set to simulate the point of contra-flexure in the beams and the column with an acceptable accuracy. Fig. 1 and Table 1 show dimensions and details of test specimens and the used formwork. One of the eleven specimens was designed and detailed according to ACI 318 [18] (control specimen) while the other ten specimens were designed and detailed according to a detail used traditionally in Egypt and several countries in the middle east to carry gravity loads only without any precautions for lateral loads caused by earthquakes (see Figs. 2 and 3). Ferrocement jackets of different layers and different orientation angles of expanded wire mesh reinforcement beside the steel angles were used for strengthening nine of the ten test specimens with traditional reinforcement while the tenth was left without strengthening to be considered as a control specimen along with the beam detailed to ACI 318 [18] (see Table 1 and Fig. 4).

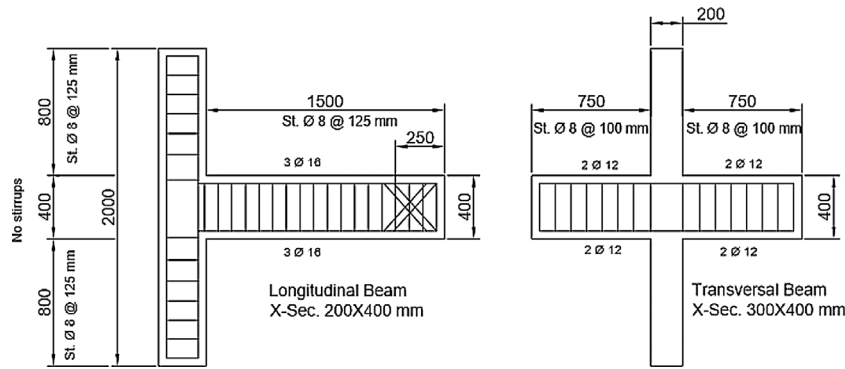
Fig. 2. Reinforcement details of a beam-column joint without adequate shear reinforcement (less confinement), REJ1.

compared to Specimen REJ1 (see Fig. 2). Qudah and Maalej [11] recorded similar observations in their study for application of engineered cementitious composites (ECC) in beam–column joints for enhanced seismic resistance.

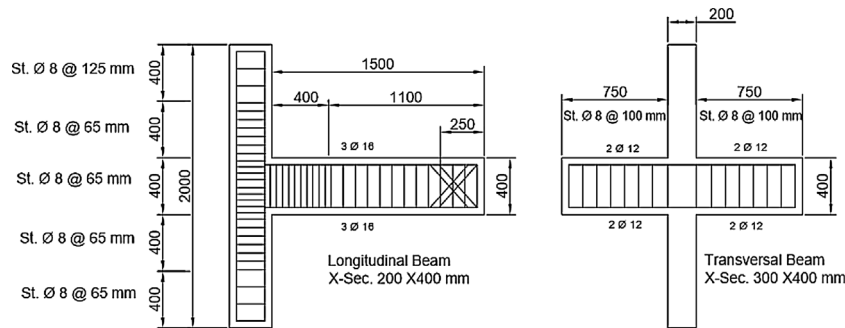
Fig. 3. Reinforcement details of beam-column joint according to ACI requirements REJ2.

The sequence of cracks initiation and propagation for Specimen REJ1 along the amplitudes of displacement is shown in Fig. 10(a). It was noticed that the flexural cracks initiated in the top and the bottom fibers of the beam at the first cycle of loading. Inclined and vertical cracks were developed in the beam between the loading point and the beam-column interface. By further displacement application, the length of previously established cracks was increased and new vertical cracks were formed near to the beam-column interface. The same behavior continued up to a displacement of 20 mm. In the subsequent cycles, the inclined cracks around the beam-column interface lengthened and joined to the vertical crack. The major vertical crack appeared in the back face of the joint. At the onset of the peak load attainment, the vertical crack widened and a part of concrete cover around this crack started spalling off with a rapid loss of load carrying capacity. The mode of failure of Specimen REJ1 was flexural shear failure in the beam near to the beam-column interface. This is similar to the findings of Qudah and Maalej [11]. Successive cracking patterns and corresponding displacement for Specimen REJ2 were shown in Fig. 10(b). Similar to REJ1, flexural shear cracks were initiated in the top and the bottom of the beam. Inclined cracks continued building up between 2 mm and 8 mm displacement with no existence of joint or column cracks. At displacement amplitude of 16 mm, few hairline cracks appeared in the column and out of plane beam near to the joint zone. At the ultimate load attainment, the beam shear cracks were fully developed and inclined beam cracks lengthened and widened. A major vertical crack was observed at the beam-column interface; further loading resulted in a gradual building up of cracks accompanied by continuous drop of the load carrying capacity without any spalling of the concrete cover. The mode of failure of Specimen REJ2 was flexural failure in the beam close to the joint region and did not suffer heavily damage as observed for REJ1 joint. It can be argued that there was adequate shear reinforcement in the joint region and in the beam for Specimen REJ2 (see Fig. 3)

recorded in Table 2, show clearly that the order of improvement in the behavior was as follows; EJANG3, EJANG2, EJ3, EJANG1, EJ6, REJ2, EJ2, EJ5, EJ1, EJ4, compared to the reference specimen with insufficient reinforcement, REJ1. The details of the specimens explained in Table 1 and shown in Figs. 2–4 may explain such improvement. It was noticed that the specimen REJ2 attained its strength constant for more cycles compared to REJ1 below the ultimate load. Although REJ1 and REJ2 have the same flexure steel reinforcement (Figs. 2 and 3), it is easily concluded that the difference in behavior is due to the confinement achieved in REJ2 by the addition of transverse reinforcement (Fig. 3).

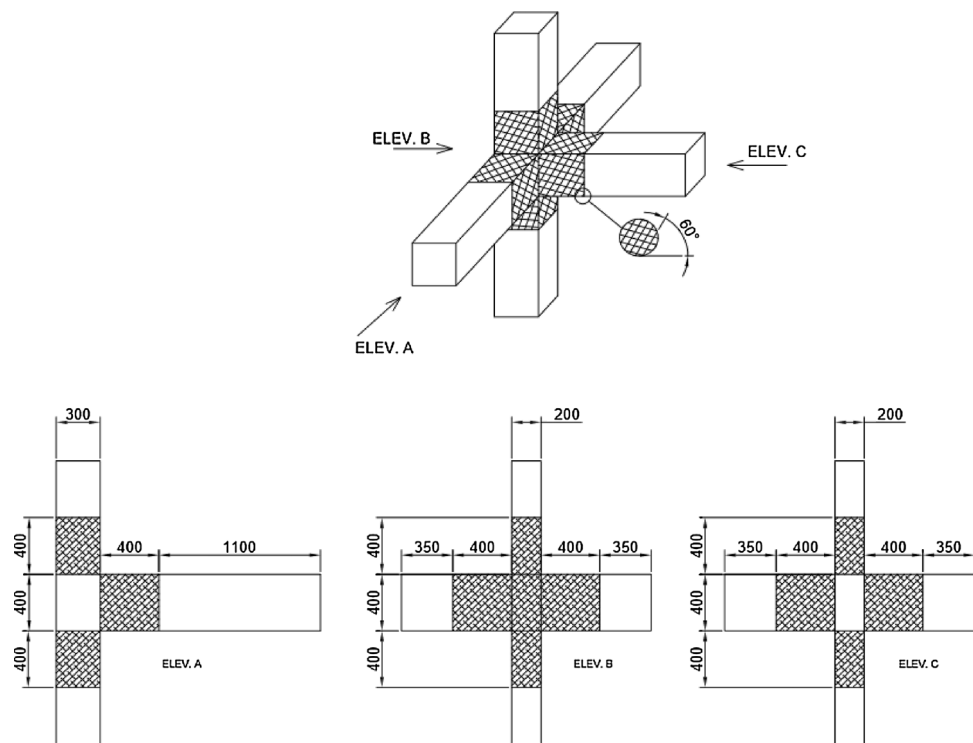
(a) Joints EJ1, EJ2, and EJ3

Fig. 4. Schematic diagram for ferrocement layers of different orientation angles around studied space joints (see Table 1).

to the developed cracks for the REJ1 specimen (see Figs. 4 (a), 6 and 10 (a)). In addition, the adequate shear reinforcement for the joint region from the start (REJ2) may be better than the repair and retrofitting of beam-column joints, which were not properly reinforced against lateral loads, REJ1.

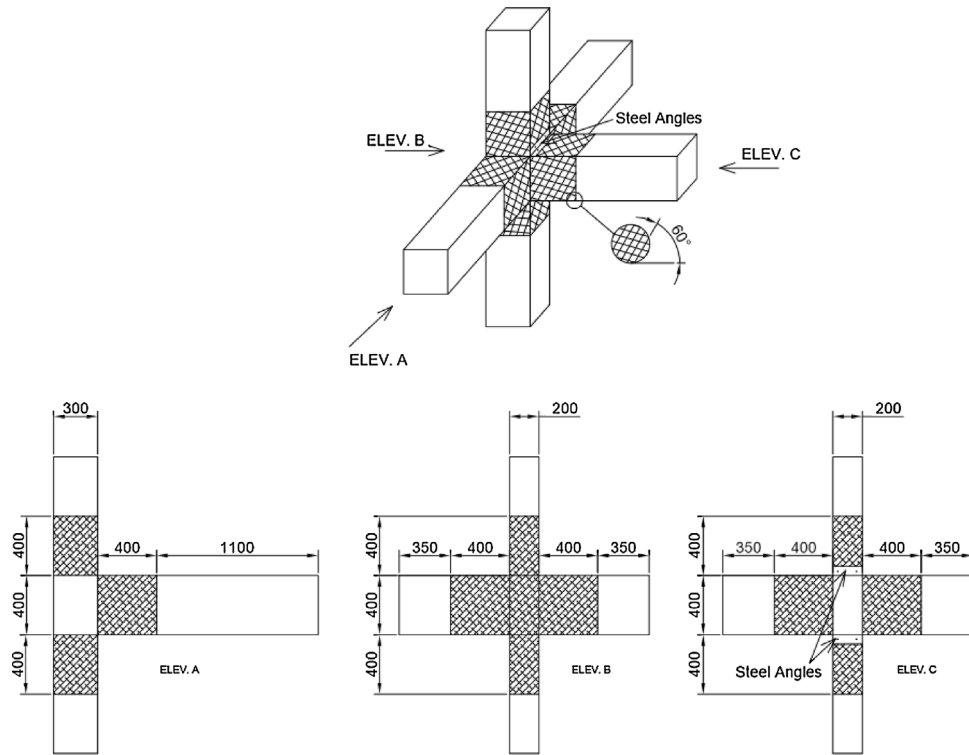
(c) Joints EJANG1, EJANG2, and EJANG3

Fig. 4. (continued)

retrofitting using steel angles 50\*50\*5 mm at the top and at the bottom fibers of the loaded beam in addition to the ferrocement layers (see Fig. 4(c)). It is worth mentioning that the surface preparation process of specimens is the most critical phase of retrofitting which needs proper understanding and care to meet the necessary requirements for retrofitting. In addition, good training is necessary for applying this technique in site for real structural joints.

Retrofitting specimens by ferrocement layers of orientation angle,  $60^\circ$ , in addition to steel angles in corners of the joint (as shown in Fig. 4(c)), showed further improvement in the behavior of such specimens, EJANG1, EJANG2 and EJANG3 compared to traditionally reinforced specimen without adequate confinement, REJ1, to different degrees. However, the behavior of specimens retrofitted by higher number of ferrocement layers is better than that retrofitting by less number of layers in the presence of stiffening by steel angles. For example, the behavior of EJ3 was better than that of EJANG1 in terms of attaining higher ultimate load and longer displacement until failure. Table 2 indicates that specimen, EJANG3, had the best performance among the other specimens. It had a maximum load of 10.04 ton in push and 9.18 ton in pull and the specimen failed in 59 mm displacement. Table 2 shows also that the properly confined specimen according to ACI 318, REJ2, attained higher ultimate loads than that of some of the retrofitted specimens such as EJ1, EJ4, EJ5, and EJ6. It can be argued that proper reinforcement of the beam-column joints according to codes of practice may be even structurally better than retrofitting of such joints. It was also noticed that using two layers or higher of ferrocement achieved significant improvement in capacity and ductility of retrofitted specimens, and adding steel angles in the corner of the joint

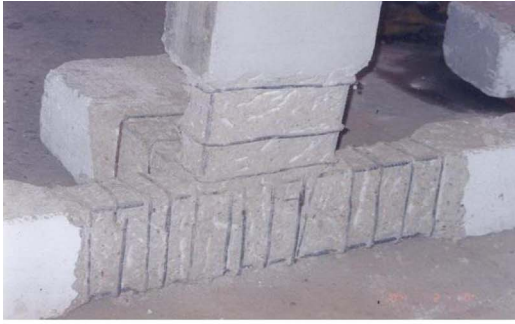
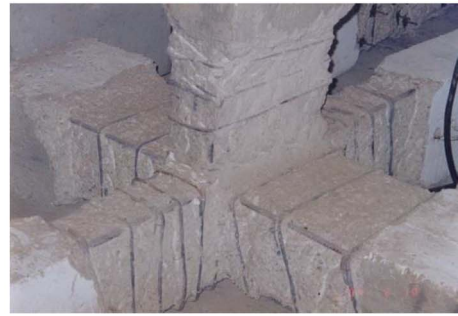
(a) Removing the concrete cover for beams and column

Fig. 5. Removing concrete cover and inserting steel dowels to ensure composite action between the ferrocement layers and concrete core.

After 28 days, the concrete cover around the joint was removed for the nine exterior specimens using a small hand-held chipping hammer. The removed cover extends 300 mm in the beam and 300 mm in the column above and below the joint. The surface of steel reinforcement was exposed and cleaned (see Fig. 5(a)). The edges of the removed cover were kept curved and roughened to prevent stress concentration. For the specimens prepared for retrofitting, staggered holes were drilled in each specimen in predefined locations (10–15 cm apart) as shown in Fig. 5(b) and (c)). Each hole of diameter 8 mm penetrated the core with 50 mm depth. The inner surfaces of the holes were roughened and cleaned from loose concrete pieces and dust using compressed air. The mixed anchoring grout was poured steadily into holes and a 6 mm galvanized high strength threaded bars (steel dowels) were inserted inside the holes to ensure composite action between the ferrocement layer and concrete core (see Fig. 5). The retrofitted specimens were wrapped by one layer of wire mesh (with overlap of 100 mm) as shown in Fig. 6. The expanded wire mesh was fixed to the embedded 6 mm, shear connectors by washers and nuts. The strengthened specimens were plastered with a thin layer of rich cement mortar (650 kg of Portland cement per  $1\text{m}^3$  of well graded sand with 0.4 as water cement ratio). The wrapped specimen was cured by water for 4 days. The same process was repeated for each layer of ferrocement. The specimens EJANG1, EJANG2, and EJANG3 were

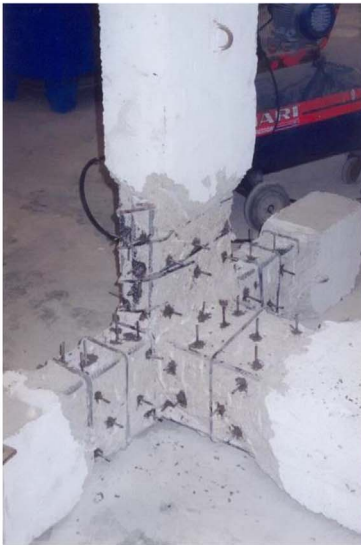
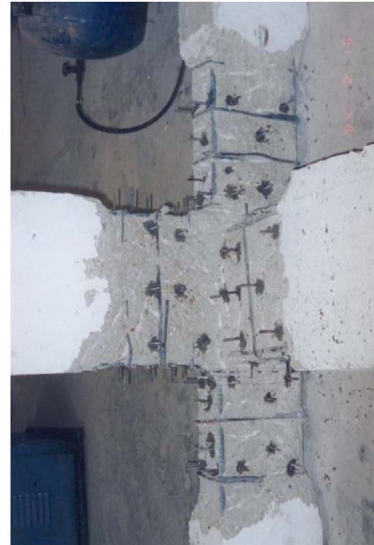
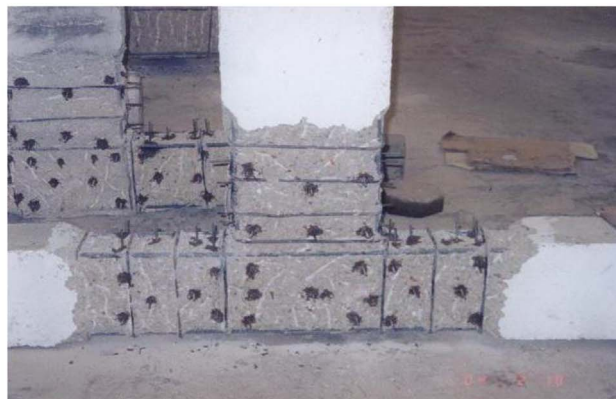
(b) Drilling holes and inserting steel dowels

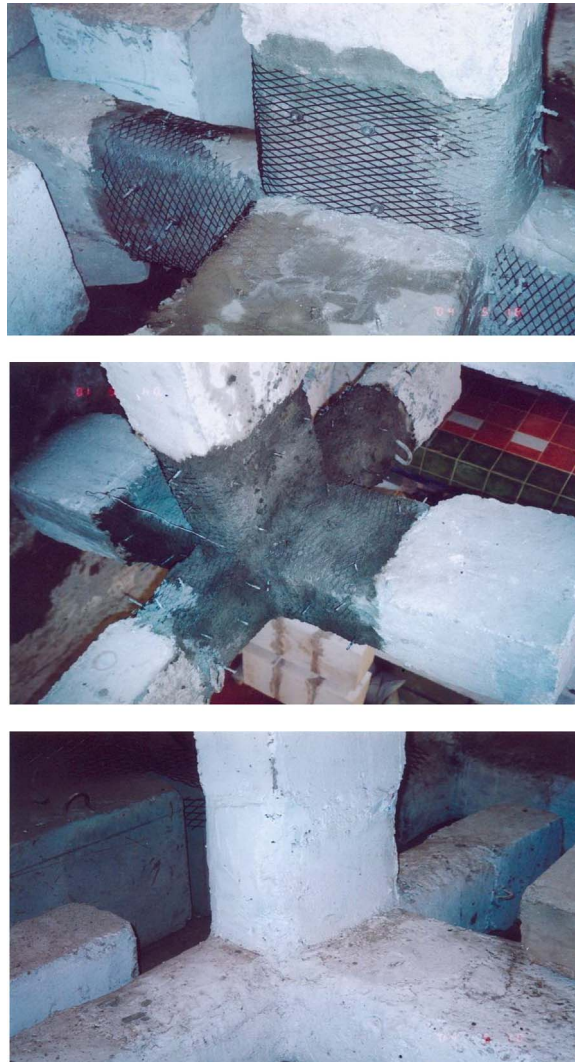
Fig. 6. Fabrication details, inserting expanded wire mesh layers and rendering them with mortar to make ferrocement layers.

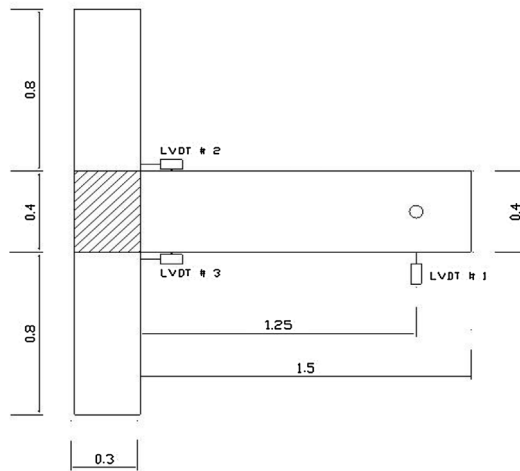
(c) LVDTs location at concrete surface

Fig. 7. Location of strain gauges (for steel) and LVDTs (for concrete).

Electrical strain gauges were adhered to the reinforcing bars of specimens at appropriate locations (see Fig. 7(a) and (b)). Linear voltage differential transducers (LVDTs) were used to measure the various types of deformations of the beam-column sub assemblage (see Fig. 7(c)). For all specimens, the loading was controlled by the displacement of the beam at the intended loading point. An axial load equals to 0.5 ultimate load of the column was applied to the column and kept constant throughout the test. Reversed cyclic displacements were applied to the free end of the beam simulating an earthquake-type loading. The same process was repeated for

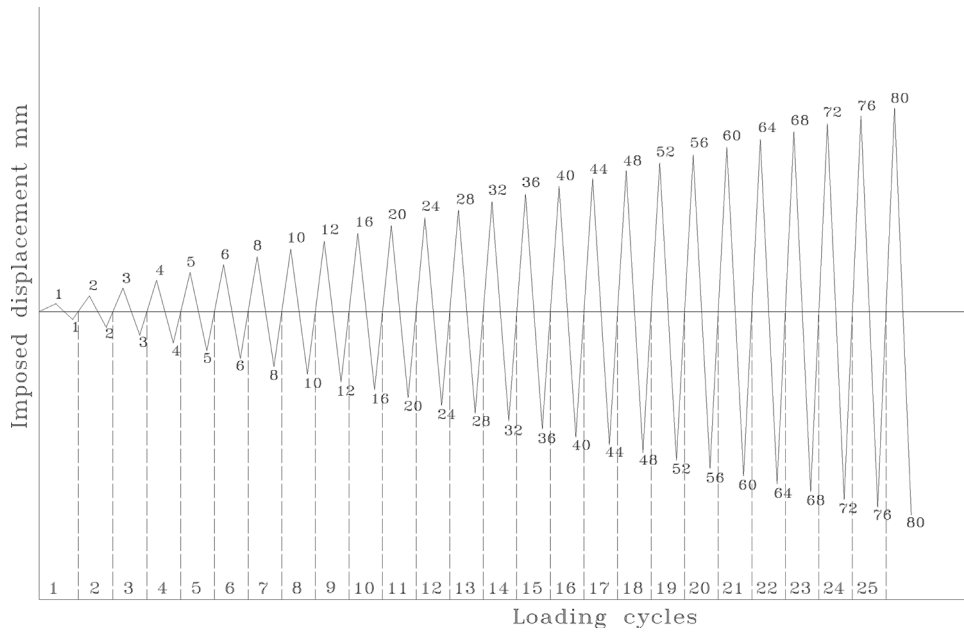
Fig. 8. Cyclic load history.

each cycle. The used displacement controlled loading history is shown in Fig. 8, the testing frame and testing process are shown in Fig. 9. This loading schedule discloses information on both strength and stiffness degradation of the specimen. Although the applied displacements in the later cycle of the proposed loading history may violate the code provision which limit the story drift, the use of such a loading history was justified in order to obtain as much information as possible about the behavior of each specimen. All the data gathered from load cells, displacement transducers, and strain gauges were recorded continuously during the test by computer controlled data acquisition system. Cracks were observed and traced for each load level.

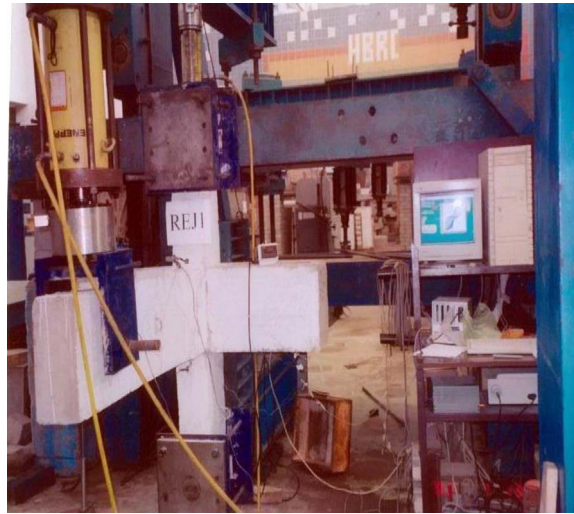
Fig. 9. Testing frame and testing process.

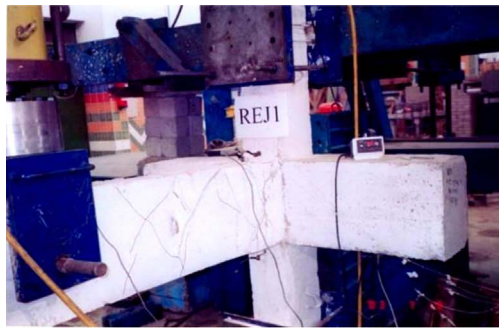
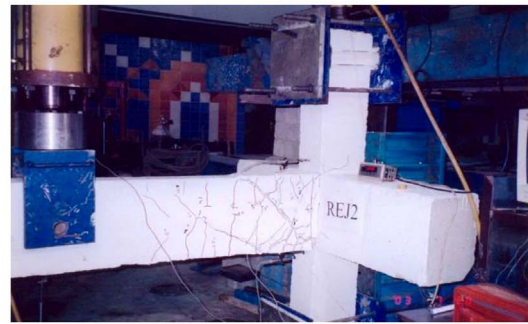
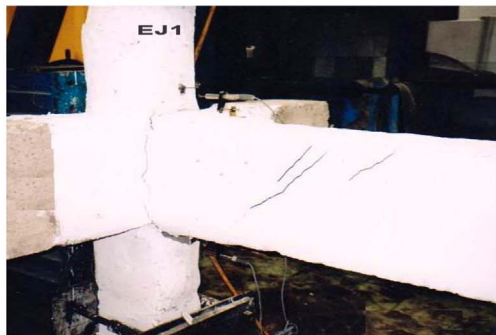
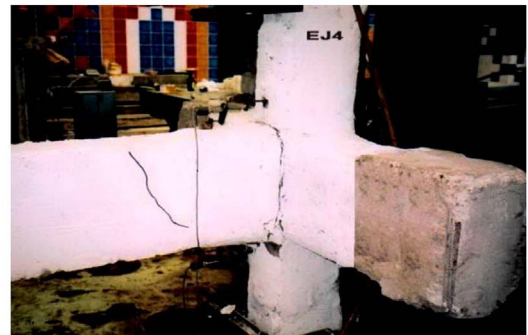
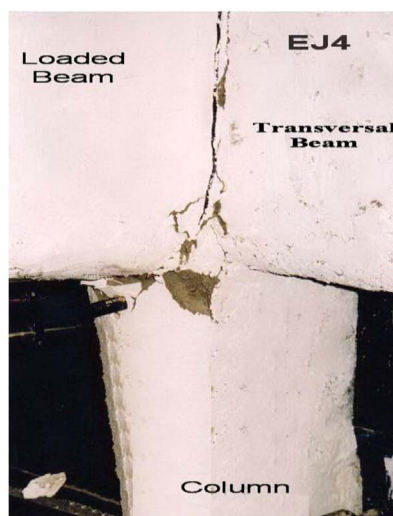
Fig. 10. Crack pattern and mode of failure for selected specimens before and after retrofitting.

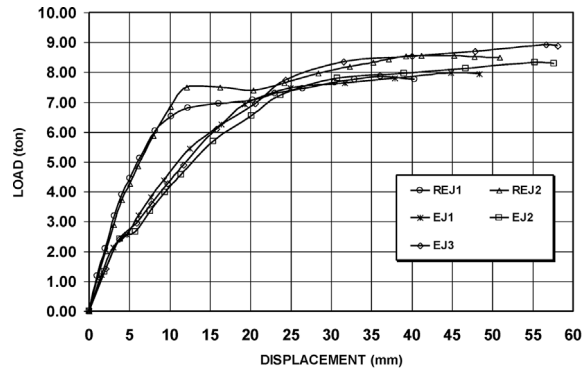
(a) Strength envelopes

Fig. 11. Strength decay, stiffness degradation and energy dissipation for specimens retrofitted by ferrocement layers of orientation angle  $60^\circ$ .

**3.3.1.1. Strength envelopes.** Fig. 11 (a) shows the load displacement relationship for the reference specimens REJ1, REJ2 and the specimens retrofitted by different ferrocement layers of orientation angle of 60° for the expanded wire mesh. It can be seen from the figure that the reference specimens show higher load than that of the retrofitted specimens at the start of cyclic loading until 12 mm displacement. After the displacement reaches 20 mm, the reference specimens and the ones retrofitted by ferrocement layers followed the same trend. The ultimate load capacity of the ACI detailed joint with sufficient shear reinforcement (good confinement), REJ2 was 8–10% higher than that of the traditionally reinforced joint REJ1 (see Table 2). Fig. 11(a) and Table 2 show that the load carrying capacity is directly proportional to the number of ferrocement layers used for strengthening. For example, the ultimate load capacity of EJ1, EJ2, and EJ3 was higher than that of REJ1 by 3.30%, 7.60%, and 15.20%, respectively. This may be attributed to the confinement enhanced by wrapping the specimens with ferrocement layers and the composite action achieved by attaching such layers to the retrofitted specimen using the shear dowels (see Figs. 5 and 6). It can be seen also that EJ1 had lower ultimate load than that of the ACI detailed joint, REJ2, while using two ferrocement layers for retrofitting, EJ2, led to an ultimate load almost similar to that of REJ2 and its ultimate displacement to failure was higher than that of REJ2 by 7% only. Increasing the number of ferrocement layers to three led to a further improvement in the ultimate capacity of Joint EJ3 over that of REJ2 (almost double as much the improvement achieved by retrofitting with two layers, Joint EJ2). It was observed that such improvement is less than that obtained by Ravichandran and Jeyasehar [2], Li et al. [9], Kannan et al. [20] and Seoud [4]. It can be argued that the exterior joints in the current research, included transversal beams to simulate the real joints in actual building reduce the effect of confinement using ferrocement layers compared with these studies in the literature.

observed for strength envelopes (see Fig. 11(a)). After 20 mm displacement, the stiffness degradation decreased with increasing ferrocement layers because of the significant confinement of the joint core since the ferrocement layers substitute the inadequate shear reinforcement in the joint region. Fig. 11(c) shows that the cumulative dissipated energy differentiates clearly between the reference specimens and those retrofitted by ferrocement layers. It can be seen also that the relationships indicated that the strengthened exterior joints with more ferrocement layers attained higher capacity of the dissipated energy. Table 4 and Fig. 11(c) show that Joints EJ1, EJ2 and EJ3 attained higher accumulated capacity of the dissipated energy than the reference traditional Joint REJ1 while the reference ACI detailed Joint REJ2 attained higher cumulative dissipated energy than that of EJ1. The figure and the table show also that the energy dissipation capacity of EJ3, retrofitted by three ferrocement layers was slightly higher than that of EJ2, retrofitted by two layers of ferrocement. Fig. 11(b), (c), Tables 3 and 4 show that Joint EJ1, retrofitted by one ferrocement layer showed stiffness degradation and cumulated dissipated energy lower than that of REJ2.

REJ2. It was observed that the ultimate load of EJ4 was less than that of the ACI detailed joint REJ2 and slightly lower than that of EJ1 (see Fig. 11(a) and Table 2). In addition, the ultimate load of EJ4 was almost the same as that of REJ1; however, it resisted a higher number of cycles prior to failure and its ultimate displacement was higher than that of REJ1 by 14%. This indicates that even that the enhancement in ultimate capacity for specimens retrofitted by ferrocement layers of orientation angle equals  $45^\circ$  was less than that for those having orientation angle  $60^\circ$ , the retrofitting itself enhances the ultimate displacement prior to failure which indicates the ductility of specimens (see Table 2). Table 2 and Fig. 12(a) show that increasing the number of layers led to an improvement of the ultimate capacity of the specimens but still to a lower degree compared with that of orientation angle  $60^\circ$ . Figs. 11 (a) and 15(a) show that the ultimate load capacities of EJ2, EJ5, EJ3 and EJ6 were higher than that of REJ1 by 7.60%, 4.30%, 15.20% and 7.5% while the ultimate load capacity of the ACI detailed space Joint REJ2 was 8.90% higher than that of the local Joint, REJ1. This shows that the improvement of specimens retrofitted by two and three layers of ferrocement with expanded wire mesh orientation,  $60^\circ$ , was higher than that of those retrofitted by two or three layers of wire mesh orientation,  $45^\circ$ . This may be attributed to the geometrical shape of the wire mesh, which makes its main reinforcement direction for  $60^\circ$  orientation, is almost perpendicular

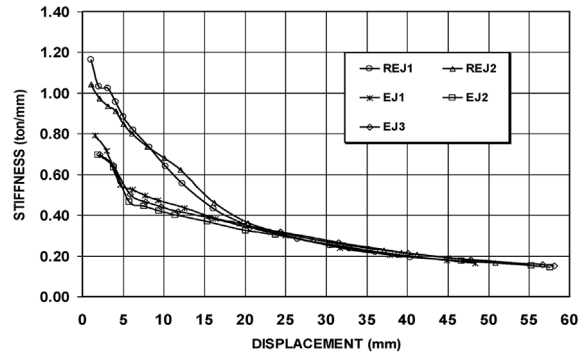
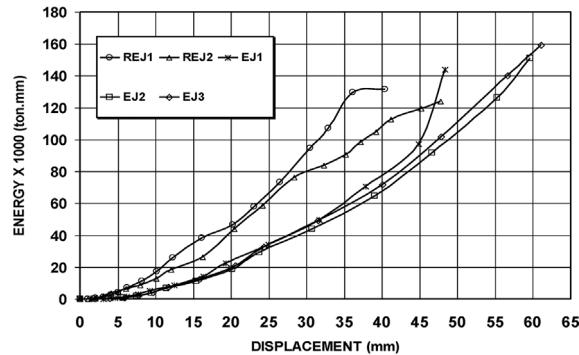
(b) Secant stiffness degradation

(c) Cumulative hysteretic energy

**3.3.1.2. Stiffness degradation and energy dissipation capacity.** The stiffness degradation and energy dissipation capacity for Specimens EJ1, EJ2, EJ3, REJ1, and REJ2 are reported in Tables 3 and 4 and the graphs are presented in Fig. 11(b) and (c), respectively. Fig. 11(b) shows that the stiffness degradation for reference specimens REJ1 and REJ2 was sharper than that of the retrofitted specimens at the beginning until the displacement reaches 20 mm and then all the specimens followed the same trend as was

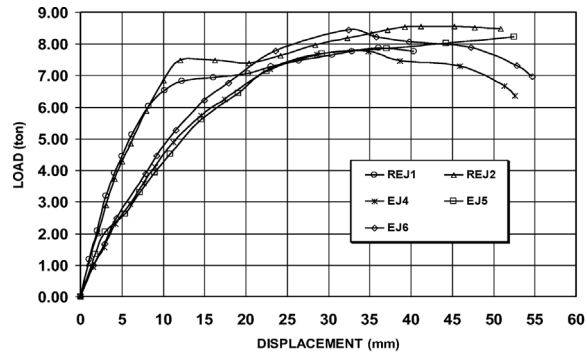
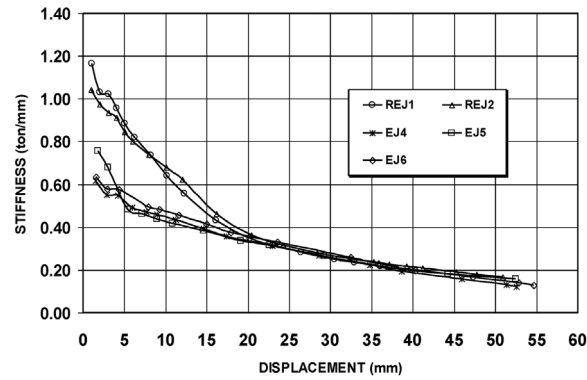
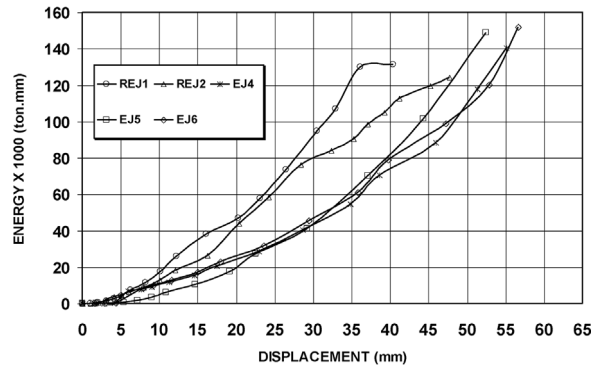
(a) Strength envelopes

(b) Secant stiffness degradation

(c) Cumulative hysteretic energy

**Fig. 12.** Strength decay, stiffness degradation and energy dissipation for specimens retrofitted by ferrocement layers of orientation angle  $45^\circ$ .

3.3.2.1. *Strength envelopes.* Fig. 12(a) shows the load carrying capacity versus displacement for the specimens retrofitted by ferrocement layers of expanded wire mesh orientation angle,  $45^\circ$ , EJ4, EJ5, and EJ6, besides the two reference samples REJ1, and

**3.3.2.2. Stiffness degradation and energy dissipation capacity.** The effect of orientation angle and confinement provided by the ferrocement layers can be observed in the stiffness degradation and energy dissipation capacity curves for upper mentioned specimens EJ4, EJ5, EJ6, REJ1, and REJ2 plotted in Fig. 12(b) and (c), respectively. The results are also reported in Tables 3 and 4. It can be seen from the figures that the specimens retrofitted by ferrocement layers of orientation angle  $45^\circ$  showed almost a similar trend as shown for specimens retrofitted by ferrocement layers of orientation angle  $60^\circ$  (see Fig. 11(b) and (c)) in terms of experiencing a uniform pattern of stiffness degradation and cumulative energy dissipation. However, specimens wrapped by ferrocement layers of orientation angle  $60^\circ$ , showed a better behavior in terms of attaining slightly higher accumulated capacity of the dissipated energy and slightly lower stiffness degradation than that of the specimens retrofitted by ferrocement layers of orientation  $45^\circ$ , especially in the late stages (see Tables 3 and 4).

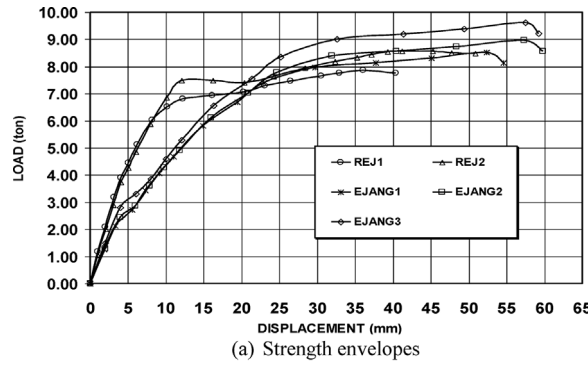
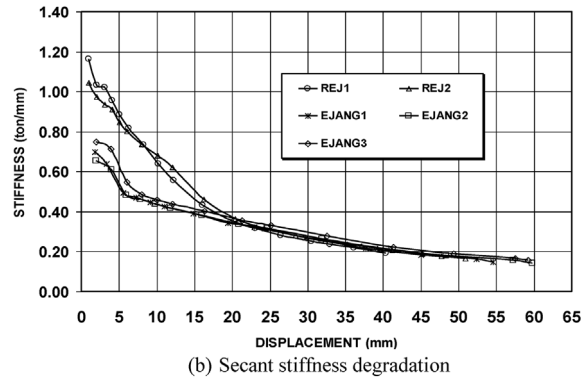
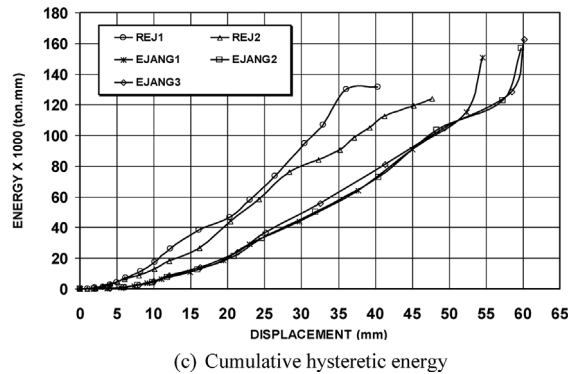
Fig. 13. Strength decay, stiffness degradation and energy dissipation for specimens retrofitted by ferrocement layers (orientation angle  $60^\circ$ ) and steel angles.

The load carrying capacity, stiffness degradation, and cumulative energy dissipation curves presented in Fig. 13 and the values

reported in Tables 2–4 illustrate the potential of strengthened joints in presence of steel angles (EJANG1, EJANG2, and EJANG3) over the reference joints REJ1 and REJ2. The figure and the tables show that inserting angles to the corners of the specimen before wrapping it by ferrocement layers enhances the overall performance of the strengthened joints compared to specimens retrofitted by ferrocement layers only shown in Fig. 11.

**3.3.3.1. Strength envelopes.** Fig. 13 (a) shows the load carrying capacity versus the displacement for the studied specimens. It can be seen from the figure and Table 2 that the ultimate load values of EJANG1, EJANG2, and EJANG3 were higher than that of local reference exterior joint REJ1 by 11%, 16.10%, and 21.80% and they were higher than that of ACI detailed exterior joint REJ2 by 2.10%, 6.64%, and 11.87%, respectively. It can be argued that the specimen REJ2 was well confined initially by proper reinforcement details. Fig. 13(a) and Table 2 show that the ultimate load of EJANG1 was higher than that of REJ1 by 11% while the ultimate load of EJ1 was higher than that of REJ1 by 3.30% only (see Fig. 12(a) and Table 2). For the specimen, EJANG2, of two layers of ferrocement and steel angles, the ultimate load was higher than that of REJ1 by 16.10% while the ultimate load of EJ2 was higher than that of REJ1 by 7.6% only. This can be attributed to the better stiffening and confinement of the joint region as a result of adding steel angles in addition to the wrapping by ferrocement layers. This technique delayed and controlled the initiation and full development of cracks, and consequently minimized the joint deformation.

**3.3.3.2. Stiffness degradation and energy dissipation capacity.** Fig. 13(b), (c), Tables 3 and 4 show that the confinement provided by the ferrocement layers in the presence of steel angles was observed in the stiffness degradation and energy dissipation capacity curves for specimens EJANG1, EJANG2, EJANG3 compared to REJ1, and REJ2. By comparing Fig. 11(b) with Fig. 13(b), it can be seen that the specimens retrofitted by ferrocement layers without and with steel angles experienced a uniform pattern of stiffness degradation. However, Table 3 shows that the stiffness of the specimens retrofitted by ferrocement in the presence of steel angles (EJANG1, EJANG2 and EJANG3) was slightly higher than that for those retrofitted by ferrocement layers only (EJ1, EJ2 and EJ3) especially in the late stages of cyclic loading. Figs. 11 (c) and 13 (c) show that the strengthened joints without and with the presence of steel angles, EJ1, EJ2, EJ3 and EJANG1, EJANG2, EJANG3 almost followed a similar trend and they attained higher capacities of the dissipated energy compared to that of the reference specimen, REJ1. However, Table 4 shows that the joints retrofitted by ferrocement and steel angles attained higher capacity of the dissipated energy than that of the retrofitted joints without steel angles. Hence, the use of ferrocement layers in the presence of steel angles in retrofitting joints without shear reinforcement would enhance the behavior of these joints and would reduce the vulnerability of these joints to excessive damage when subjected to seismic loading.
